# Access Compliance Report

## Public Rights-of-Way (Curb Ramps)

Intersection ID: 18488	Main Street: ABBEY_PL	Cross Street: PARK_RD	Location: NW
ADA ID: C5B42B7EEC3E	Ramp Type: Perp	Initial Pass/Fail: Fail	Overall Compliance: No
			Severity Score: 13.75

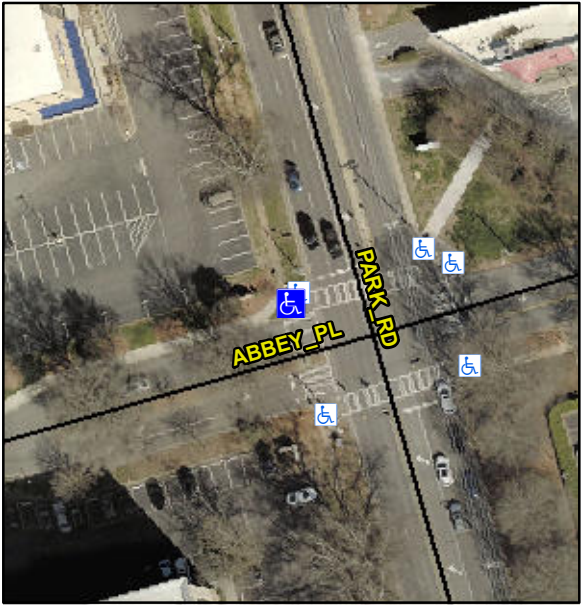
Possible Solutions:		<b>Compliance</b>	<b>Description</b>	<b>Data</b>
	<b>Remove &amp; Replace Entire Ramp.</b>		<b>No</b>	Ramp Length (in)	44.0
			<b>Yes</b>	Ramp Width (in)	48.0
			<b>N/A</b>	Flare Type LT	N/A
			<b>N/A</b>	Flare Slope LT (%)	N/A
			<b>N/A</b>	Flare Traversable LT?	N/A
			<b>N/A</b>	Landing Length (in)	N/A
			<b>N/A</b>	Landing Width (in)	N/A
			<b>N/A</b>	Landing Slope (%)	N/A
			<b>N/A</b>	Landing X Slope (%)	N/A
<p>Surveyor Notes:</p> <p><b>N/A</b></p> <p>PROW/ADA:</p> <p><b>Not Found, R304.2.2, R304.5.3</b></p>			<b>N/A</b>	Flare Type RT	N/A
			<b>N/A</b>	Flare Slope RT (%)	N/A
			<b>N/A</b>	Flare Traversable RT?	N/A
			<b>N/A</b>	DWS Provided?	N/A
			<b>N/A</b>	DWS Contrast?	N/A
			<b>N/A</b>	DWS Length (in)	N/A
			<b>N/A</b>	DWS Full Width?	N/A
			<b>N/A</b>	DWS Offset (in)	N/A
			<b>N/A</b>	Shared Landing?	N/A

<b>N/A</b>	Gutter Ponding?	N/A
			<b>N/A</b>	Gutter Lip Ht (in)	N/A
			<b>N/A</b>	Painted X Walk1?	Yes
				X Walk 1 Direction	To S
			<b>N/A</b>	X Walk 1 Width (in)	190.0
				X Walk 1 Slope (%)	3.7
				X Walk 1 X Slope (%)	1.9
			<b>N/A</b>	Ramp inside XWalk1?	Yes
			<b>N/A</b>	Road Slope (%)	N/A
			<b>N/A</b>	Road X Slope (%)	N/A
			<b>N/A</b>	Any Obstructions?	N/A
				Obstruction Type	
			<b>N/A</b>		
			<b>N/A</b>		
			<b>N/A</b>		
			<b>N/A</b>		
			<b>N/A</b>		
			<b>N/A</b>		
			<b>N/A</b>		
			<b>N/A</b>		
			<b>N/A</b>		
Total Cost:		\$ 1850.00			
			<b>N/A</b>		
			<b>Yes</b>	Surface Condition? (G/P)	Good
