Access Compliance Report

Public Rights-of-Way

(Curb Ramps)

Intersection ID: 44906	Main Street: OAK_DR	Cross Street: HAZELCROFT_LN	Location: SE
ADA ID: C5B5DD3762C2	Ramp Type: PerpDiag	Initial Pass/Fail: Fail	Overall Compliance: No
Severity Score: 31.25			
Codes/Mitigation Info/Possible Solution		Field Measurements/Component Compliance

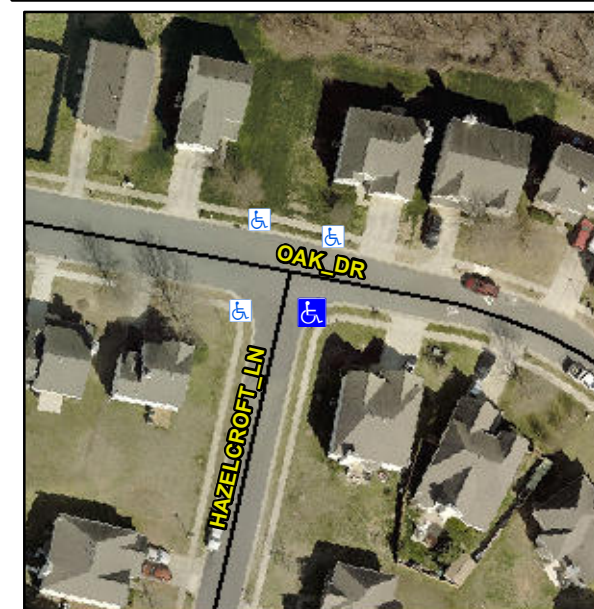
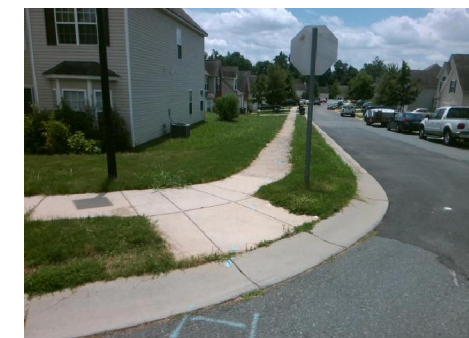
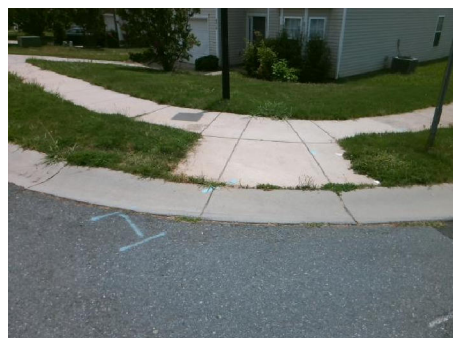
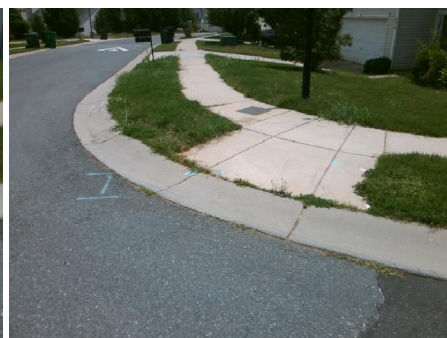
Not Found, R304.5.1, R304.2.2, R304.5.3

Compliance	Description	Data	Compliance	Description	Data
N/A	Ramp Length (in)	48.0	No	Ramp Slope (%)	8.6
No	Ramp Width (in)	34.0	No	Ramp XSlope (%)	3.9
N/A	Flare Type LT	N/A	N/A	Flare Type RT	N/A
N/A	Flare Slope LT (%)	N/A	N/A	Flare Slope RT (%)	N/A
N/A	Flare Traversable LT?	N/A	N/A	Flare Traversable RT?	N/A
N/A	Landing Length (in)	N/A	N/A	DWS Provided?	N/A
N/A	Landing Width (in)	N/A	N/A	DWS Contrast?	N/A
N/A	Landing Slope (%)	N/A	N/A	DWS Length (in)	N/A
N/A	Landing X Slope (%)	N/A	N/A	DWS Full Width?	N/A
N/A	Landing Curb? (Y/N)	N/A	N/A	DWS Offset (in)	N/A
N/A	Shared Landing?	N/A			
N/A	Gutter Ponding?	N/A	N/A	Gutter Slope (%)	N/A
N/A	Gutter Lip Ht (in)	N/A	N/A	Gutter X Slope (%)	N/A
N/A	Painted X Walk1?	No	N/A	Painted X Walk2?	No
	X Walk 1 Direction	To NE		X Walk 2 Direction	To NW
N/A	X Walk 1 Width (in)	N/A	N/A	X Walk 2 Width (in)	N/A
	X Walk 1 Slope (%)	6.0		X Walk 2 Slope (%)	0.0
	X Walk 1 X Slope (%)	1.6		X Walk 2 X Slope (%)	3.2

N/A	Ramp inside XWalk1?	N/A	N/A	Ramp inside XWalk2?	N/A
	Road Slope (%)	2.6	N/A	Clear Space?	N/A
	Road X Slope (%)	1.5	N/A	Clear Space to XWalk (in)	N/A
N/A	Any Obstructions?	N/A	N/A	Storm Grate/Utility Hazard?	N/A
	Obstruction Type			Storm Grate/Utility Type	
		N/A			N/A
			Yes	Surface Condition? (G/P)	Good

Possible Solutions:

Remove & Replace Curb Ramp With Two New Directional Ramps or Equivalent.
