Access Compliance Report

Public Rights-of-Way (Curb Ramps)

Intersection ID: 50611	Main Street: COTTON_GUM_RD	Cross Street: DOWNY_BIRCH_RD	Location: SW
ADA ID: C5B8BF2967BC	Ramp Type: BlendTrans1	Initial Pass/Fail: Fail	Overall Compliance: No
Severity Score: 25			
Codes/Mitigation Info/Possible Solution		Field Measurements/Component Compliance

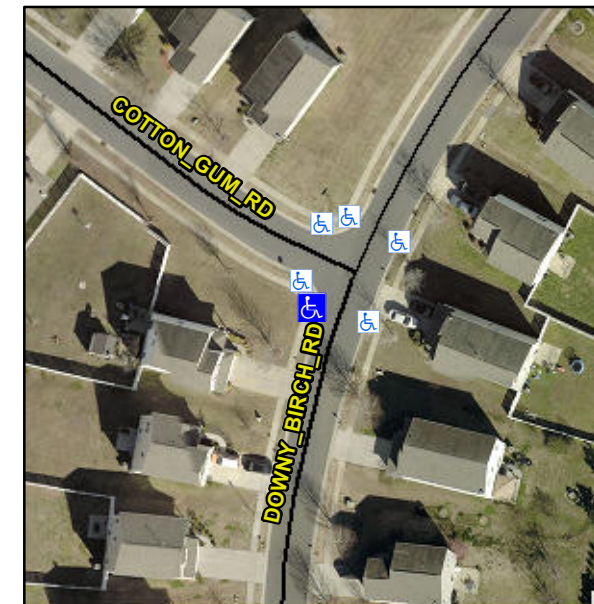
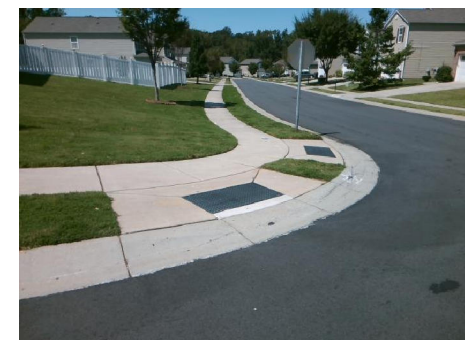
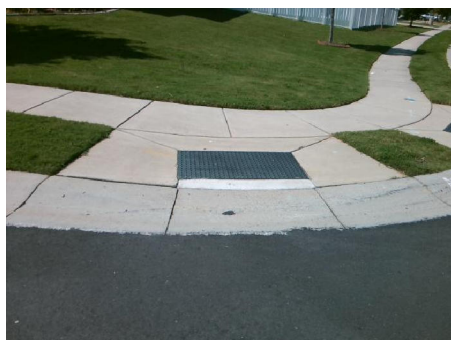
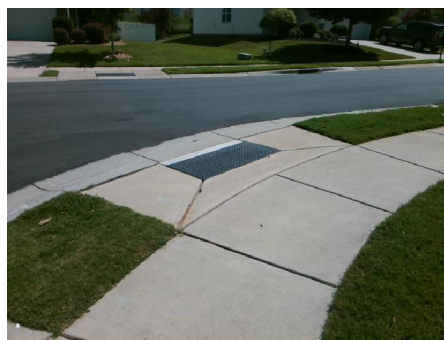
Not Found, R304.5.3

Compliance	Description	Data	Compliance	Description	Data
N/A	Ramp Length (in)	48.0	Yes	BlendTrans Slope (%)	3.7
Yes	Ramp Width (in)	48.0	No	BlendTrans XSlope (%)	7.3
N/A	Flare Type LT	N/A	N/A	Flare Type RT	N/A
N/A	Flare Slope LT (%)	N/A	N/A	Flare Slope RT (%)	N/A
N/A	Flare Traversable LT?	N/A	N/A	Flare Traversable RT?	N/A
N/A	Landing Length (in)	N/A	N/A	DWS Provided?	N/A
N/A	Landing Width (in)	N/A	N/A	DWS Contrast?	N/A
N/A	Landing Slope (%)	N/A	N/A	DWS Length (in)	N/A
N/A	Landing X Slope (%)	N/A	N/A	DWS Full Width?	N/A
N/A	Landing Curb? (Y/N)	N/A	N/A	DWS Offset (in)	N/A
N/A	Shared Landing?	N/A			
N/A	Gutter Ponding?	N/A	N/A	Gutter Slope (%)	N/A
N/A	Gutter Lip Ht (in)	N/A	N/A	Gutter X Slope (%)	N/A
N/A	Painted X Walk1?	No	N/A	Painted X Walk2?	N/A
	X Walk 1 Direction	To E		X Walk 2 Direction	N/A
	X Walk 1 Width (in)	N/A		X Walk 2 Width (in)	N/A
	X Walk 1 Slope (%)	4.4		X Walk 2 Slope (%)	N/A
	X Walk 1 X Slope (%)	4.5		X Walk 2 X Slope (%)	N/A

N/A	Ramp inside XWalk1?	N/A	N/A	Ramp inside XWalk2?	N/A
	Road Slope (%)	4.5		Clear Space?	N/A
	Road X Slope (%)	4.4	N/A	Clear Space to XWalk (in)	N/A
N/A	Any Obstructions?	N/A	N/A	Storm Grate/Utility Hazard?	N/A
	Obstruction Type			Storm Grate/Utility Type	
		N/A			N/A
			Yes	Surface Condition? (G/P)	Good
			No	Curb Slope (%)	10.4

Remove & Replace Curb Ramp With Two New Directional Ramps or Equivalent.
