Access Compliance Report

Public Rights-of-Way

(Curb Ramps)

Intersection ID: 48195	Main Street: BLAKENEY CENTRE DR	Cross Street: REA RD	Location: W
ADA ID: C5BA69536EC6	Ramp Type: BlendTrans2	Initial Pass/Fail: Fail	Overall Compliance: No
Codes/Mitigation Info/Possible Solution		Field Measurements/Component Compliance	
Severity Score: 8.75

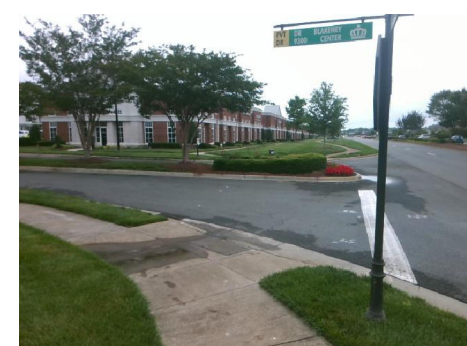
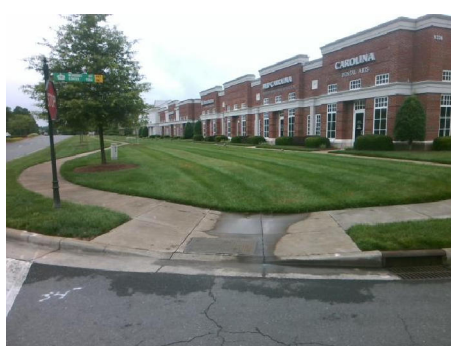
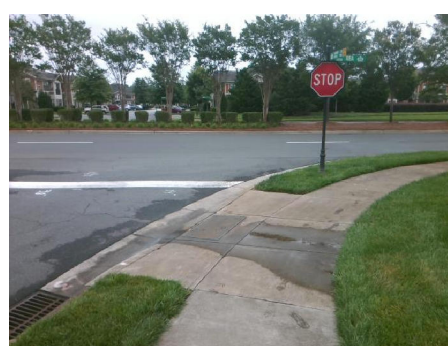
Compliance	Description	Data	Compliance	Description	Data
N/A	Ramp Length (in)	101.0	Yes	BlendTrans Slope (%)	4.7
No	Ramp Width (in)	47.0	Yes	BlendTrans XSlope (%)	1.0
N/A	Flare Type LT	N/A	N/A	Flare Type RT	N/A
N/A	Flare Slope LT (%)	N/A	N/A	Flare Slope RT (%)	N/A
N/A	Flare Traversable LT?	N/A	N/A	Flare Traversable RT?	N/A
N/A	Landing Length (in)	N/A	N/A	DWS Provided?	N/A
N/A	Landing Width (in)	N/A	N/A	DWS Contrast?	N/A
N/A	Landing Slope (%)	N/A	N/A	DWS Length (in)	N/A
N/A	Landing X Slope (%)	N/A	N/A	DWS Full Width?	N/A
N/A	Landing Curb? (Y/N)	N/A	N/A	DWS Offset (in)	N/A
N/A	Shared Landing?	N/A			
N/A	Gutter Ponding?	N/A	N/A	Gutter Slope (%)	N/A
N/A	Gutter Lip Ht (in)	N/A	N/A	Gutter X Slope (%)	N/A
N/A	Painted X Walk1?	No	N/A	Painted X Walk2?	N/A
	X Walk 1 Direction	To NE		X Walk 2 Direction	N/A
	X Walk 1 Width (in)	N/A		X Walk 2 Width (in)	N/A
	X Walk 1 Slope (%)	2.7		X Walk 2 Slope (%)	N/A
	X Walk 1 X Slope (%)	2.4		X Walk 2 X Slope (%)	N/A

N/A	Ramp inside XWalk1?	N/A	N/A	Ramp inside XWalk2?	N/A
	Road Slope (%)	2.4		Clear Space?	N/A
	Road X Slope (%)	2.7	N/A	Clear Space to XWalk (in)	N/A
N/A	Any Obstructions?	N/A	N/A	Storm Grate/Utility Hazard?	N/A
	Obstruction Type			Storm Grate/Utility Type	
		N/A			N/A
			Yes	Surface Condition? (G/P)	Good
			No	Curb Slope (%)	9.8

Remove & Replace Curb Ramp With Two New Directional Ramps or Equivalent.
