## **Access Compliance Report Public Rights-of-Way** (Curb Ramps)

Intersection ID: 11077 Main Street: DUCKWORTH AV **Cross Street: WESLEY HEIGHTS WY** Location: N **Severity Score:** 42.5 ADA ID: C5C689CD7588 Ramp Type: PerpDiag Initial Pass/Fail: Fail **Overall Compliance: No**

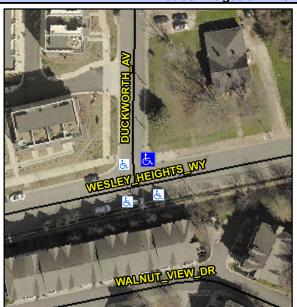
Yes N/A Ramp Length (in) 89.0 Ramp Slope (%) 7.5 No Ramp XSlope (%) No Ramp Width (in) 32.0 11.8 N/A N/A Flare Type LT N/A Flare Type RT N/A N/A N/A N/A Flare Slope RT (%) N/A Flare Slope LT (%) N/A Flare Traversable LT? N/A N/A Flare Traversable RT? N/A N/A N/A N/A **DWS Provided?** N/A Landing Length (in) N/A Landing Width (in) N/A N/A **DWS Contrast?** N/A N/A N/A N/A Landing Slope (%) DWS Length (in) N/A N/A Landing X Slope (%) N/A N/A DWS Full Width? N/A N/A Landing Curb? (Y/N) N/A N/A DWS Offset (in) N/A N/A N/A Shared Landing? N/A **Gutter Ponding?** N/A N/A Gutter Slope (%) N/A N/A Gutter Lip Ht (in) N/A N/A Gutter X Slope (%) N/A N/A Painted X Walk1? No N/A Painted X Walk2? No X Walk 1 Direction To W X Walk 2 Direction To S N/A N/A X Walk 1 Width (in) X Walk 2 Width (in) N/A X Walk 1 Slope (%) 2.6 X Walk 2 Slope (%) 0.8 X Walk 1 X Slope (%) 11.4 X Walk 2 X Slope (%) 4.5 N/A N/A N/A Ramp inside XWalk2? N/A Ramp inside XWalk1? Road Slope (%) 10.2 N/A Clear Space? N/A N/A Road X Slope (%) 3.8 Clear Space to XWalk (in) N/A N/A N/A N/A Any Obstructions? Storm Grate/Utility Hazard? N/A **Obstruction Type** Storm Grate/Utility Type N/A N/A Yes Surface Condition? (G/P) Good

Possible Solutions: Compliance Description Remove & Replace Curb Ramp With Two New Directional Ramps or Equivalent. Surveyor Notes: N/A PROW/ADA: Not Found, R304.5.1, R304.5.3
