# Access Compliance Report

## Public Rights-of-Way

### (Curb Ramps)

Intersection ID: N/A	Main Street: PERIMETER_PY	Cross Street: N/A	Location: SE
ADA ID: C5CC182CAC14	Ramp Type: PerpDiag	Initial Pass/Fail: Pass	Overall Compliance: No
Severity Score: 10.25			
Codes/Mitigation Info/Possible Solution		Field Measurements/Component Compliance

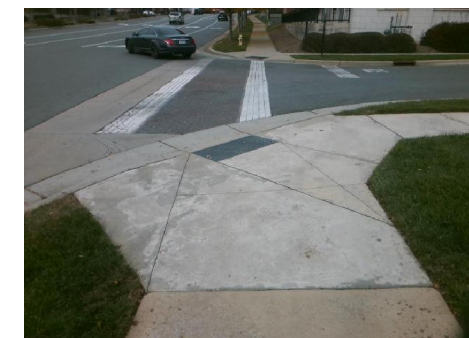
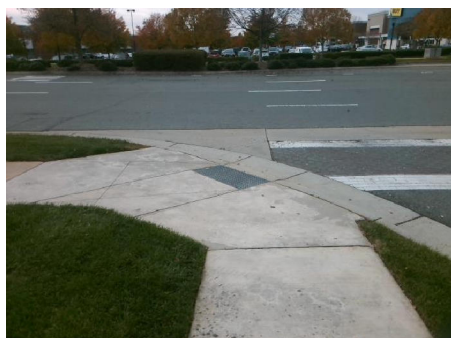
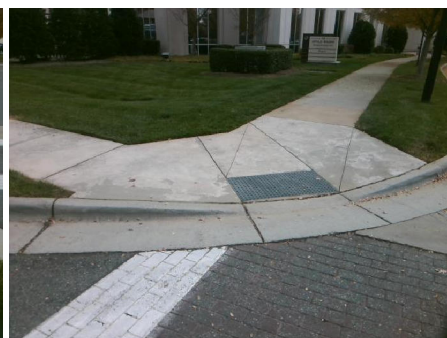
Compliance	Description	Data	Compliance	Description	Data
N/A	Ramp Length (in)	96.0	Yes	Ramp Slope (%)	5.4
Yes	Ramp Width (in)	48.0	No	Ramp XSlope (%)	2.3
N/A	Flare Type LT	Sloped	N/A	Flare Type RT	N/A
N/A	Flare Slope LT (%)	8.6	Yes	Flare Slope RT (%)	3.2
N/A	Flare Traversable LT?	Yes	N/A	Flare Traversable RT?	Yes
No	Landing Length (in)	N/A	Yes	DWS Provided?	Yes
No	Landing Width (in)	N/A	Yes	DWS Contrast?	Yes
No	Landing Slope (%)	N/A	Yes	DWS Length (in)	24.5
No	Landing X Slope (%)	N/A	Yes	DWS Full Width?	Yes
N/A	Landing Curb? (Y/N)	No	Yes	DWS Offset (in)	1.5
N/A	Shared Landing?	No			
Yes	Gutter Ponding?	No	Yes	Gutter Slope (%)	4.3
Yes	Gutter Lip Ht (in)	0.0	No	Gutter X Slope (%)	2.4
N/A	Painted X Walk1?	Yes	N/A	Painted X Walk2?	No
	X Walk 1 Direction	To N		X Walk 2 Direction	To W
N/A	X Walk 1 Width (in)	70.5	N/A	X Walk 2 Width (in)	N/A
	X Walk 1 Slope (%)	2.6		X Walk 2 Slope (%)	2.3
	X Walk 1 X Slope (%)	0.6		X Walk 2 X Slope (%)	3.5

Yes	Ramp inside XWalk1?	Yes	N/A	Ramp inside XWalk2?	N/A
	Road Slope (%)	1.6	N/A	Clear Space?	Yes
	Road X Slope (%)	1.8	N/A	Clear Space to XWalk (in)	N/A
Yes	Any Obstructions?	No	Yes	Storm Grate/Utility Hazard?	No
	Obstruction Type			Storm Grate/Utility Type	
		N/A			N/A
			Yes	Surface Condition? (G/P)	Good

**Remove & Replace Curb Ramp With Two New Directional Ramps or Equivalent. Remove & Replace Gutter.**

**Not Found, R304.5.3, R304.2.1, R304.2.2-Perp, R304.3.2-Para**
