Access Compliance Report

Public Rights-of-Way

(Curb Ramps)

Intersection ID: 23702	Main Street: COOL_SPRINGS_LN	Cross Street: REA_RD	Location:	W
ADA ID: C5D140C3122F	Ramp Type: PerpDiag	Initial Pass/Fail: Fail	Overall Compliance: No	Severity Score: 12.5

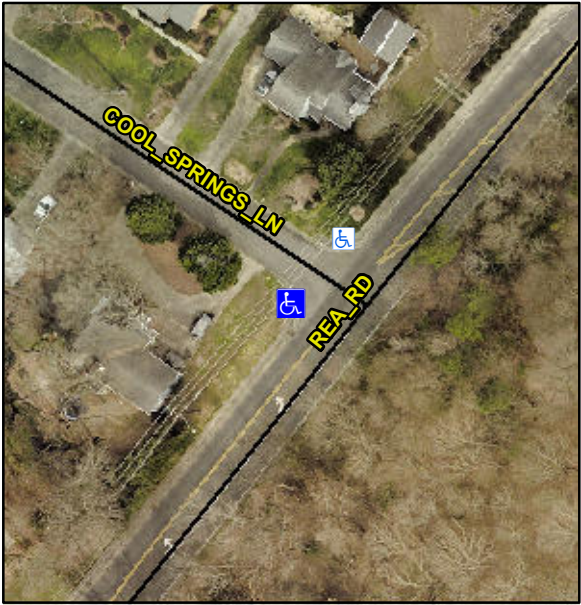
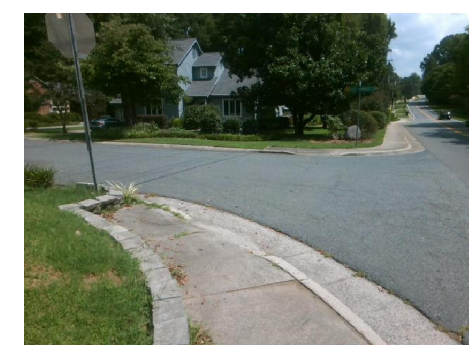
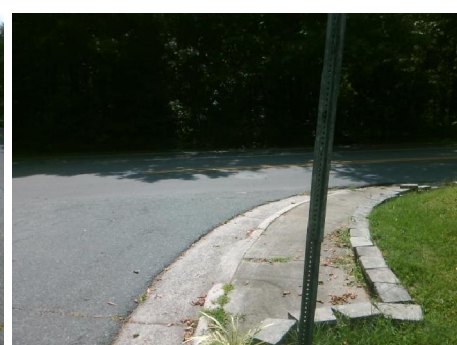
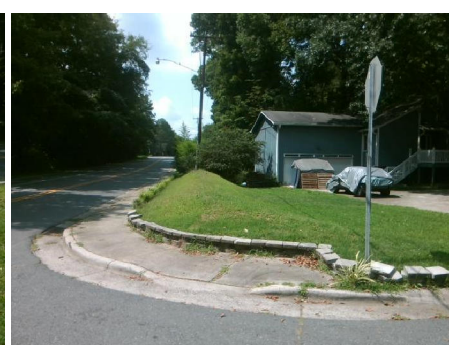
Possible Solutions:		Compliance	Description	Data
	Remove & Replace Curb Ramp With Two New Directional Ramps or Equivalent.		No	Ramp Length (in)	48.0
			Yes	Ramp Width (in)	48.0
			N/A	Flare Type LT	N/A
			N/A	Flare Slope LT (%)	N/A
			N/A	Flare Traversable LT?	N/A
			N/A	Landing Length (in)	N/A
			N/A	Landing Width (in)	N/A
			N/A	Landing Slope (%)	N/A
			N/A	Landing X Slope (%)	N/A
<p>Surveyor Notes:</p> <p>N/A</p> <p>PROW/ADA:</p> <p>Not Found, R304.2.2</p>			N/A	Flare Type RT	N/A
			N/A	Flare Slope RT (%)	N/A
			N/A	Flare Traversable RT?	N/A
			N/A	DWS Provided?	N/A
			N/A	DWS Contrast?	N/A
			N/A	DWS Length (in)	N/A
			N/A	DWS Full Width?	N/A
			N/A	DWS Offset (in)	N/A
			N/A	Gutter Ponding?	N/A
			N/A	Gutter Lip Ht (in)	N/A
<p>Total Cost:</p> <p>\$ 3200.00</p>			No	Painted X Walk1?	No
			N/A	X Walk 1 Direction	To SE
			N/A	X Walk 1 Width (in)	N/A

N/A	X Walk 1 Slope (%)	0.7
			N/A	X Walk 1 X Slope (%)	1.4
			N/A	Ramp inside XWalk1?	N/A
			N/A	Road Slope (%)	0.7
			N/A	Road X Slope (%)	0.9
			N/A	Any Obstructions?	N/A
			N/A	Obstruction Type	N/A
			N/A	X Walk 2 Direction	To NE
			N/A	X Walk 2 Width (in)	N/A
			N/A	X Walk 2 Slope (%)	1.3
			N/A	X Walk 2 X Slope (%)	1.4
			N/A	Ramp inside XWalk2?	N/A
			N/A	Clear Space?	N/A
			N/A	Clear Space to XWalk (in)	N/A
			N/A	Storm Grate/Utility Hazard?	N/A
			N/A	Storm Grate/Utility Type	N/A
			Yes	Surface Condition? (G/P)	Good
