Access Compliance Report

Public Rights-of-Way

(Curb Ramps)

Intersection ID: 2983	Main Street: YELLOW_ROSE_LN	Cross Street: BROWNE_RD	Location: SW
ADA ID: C5D1E2E50C22	Ramp Type: Perp	Initial Pass/Fail: Fail	Overall Compliance: No
Severity Score: 10			
Codes/Mitigation Info/Possible Solution		Field Measurements/Component Compliance

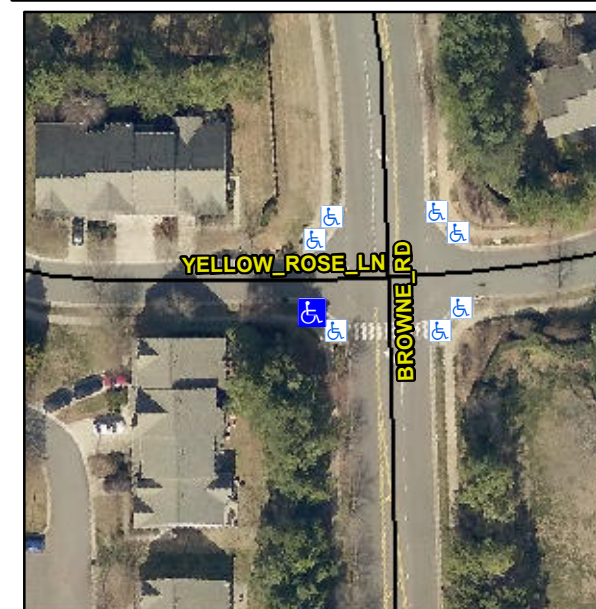
R304.5.1, R304.5.3

Compliance	Description	Data	Compliance	Description	Data
N/A	Ramp Length (in)	68.5	Yes	Ramp Slope (%)	5.3
No	Ramp Width (in)	41.0	No	Ramp XSlope (%)	5.0
N/A	Flare Type LT	N/A	N/A	Flare Type RT	N/A
N/A	Flare Slope LT (%)	N/A	N/A	Flare Slope RT (%)	N/A
N/A	Flare Traversable LT?	N/A	N/A	Flare Traversable RT?	N/A
N/A	Landing Length (in)	N/A	N/A	DWS Provided?	N/A
N/A	Landing Width (in)	N/A	N/A	DWS Contrast?	N/A
N/A	Landing Slope (%)	N/A	N/A	DWS Length (in)	N/A
N/A	Landing X Slope (%)	N/A	N/A	DWS Full Width?	N/A
N/A	Landing Curb? (Y/N)	N/A	N/A	DWS Offset (in)	N/A
N/A	Shared Landing?	N/A			
N/A	Gutter Ponding?	N/A	N/A	Gutter Slope (%)	N/A
N/A	Gutter Lip Ht (in)	N/A	N/A	Gutter X Slope (%)	N/A
N/A	Painted X Walk1?	No	N/A	Painted X Walk2?	N/A
	X Walk 1 Direction	To N		X Walk 2 Direction	N/A
N/A	X Walk 1 Width (in)	N/A	N/A	X Walk 2 Width (in)	N/A
	X Walk 1 Slope (%)	4.3		X Walk 2 Slope (%)	N/A
	X Walk 1 X Slope (%)	2.3		X Walk 2 X Slope (%)	N/A

N/A	Ramp inside XWalk1?	N/A	N/A	Ramp inside XWalk2?	N/A
	Road Slope (%)	N/A	N/A	Clear Space?	N/A
	Road X Slope (%)	N/A	N/A	Clear Space to XWalk (in)	N/A
N/A	Any Obstructions?	N/A	N/A	Storm Grate/Utility Hazard?	N/A
	Obstruction Type			Storm Grate/Utility Type	
		N/A			N/A
		Yes		Surface Condition? (G/P)	Good

Possible Solutions:

Remove & Replace Entire Ramp.

Total Cost: \$ 1850.00
