Access Compliance Report

Public Rights-of-Way

(Curb Ramps)

Intersection ID: N/A	Main Street: SCHOLASTIC_DR	Cross Street: CLEMS_BRANCH_DR	Location: SW
ADA ID: C5D47B1AAED7	Ramp Type: Perp	Initial Pass/Fail: Fail	Overall Compliance: No
Severity Score: 25			
Codes/Mitigation Info/Possible Solution		Field Measurements/Component Compliance

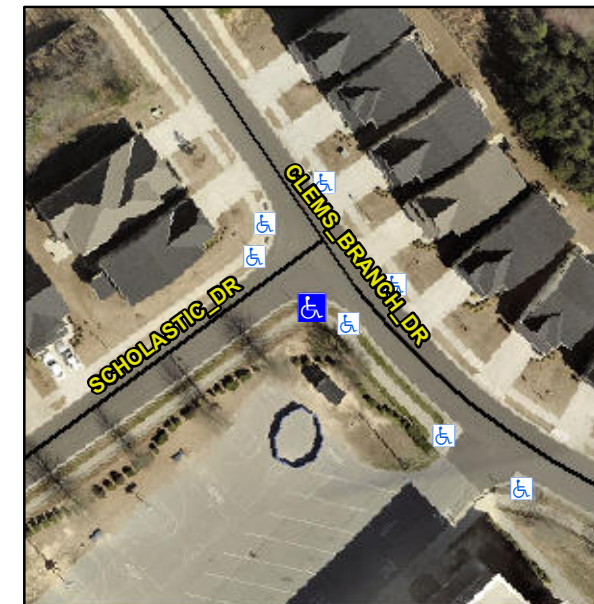
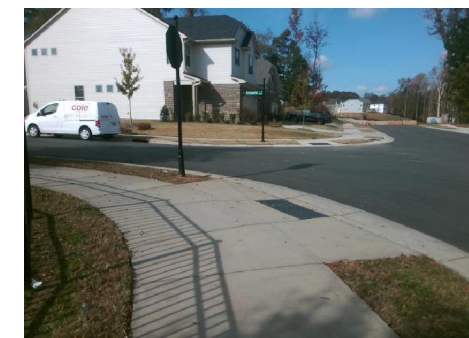
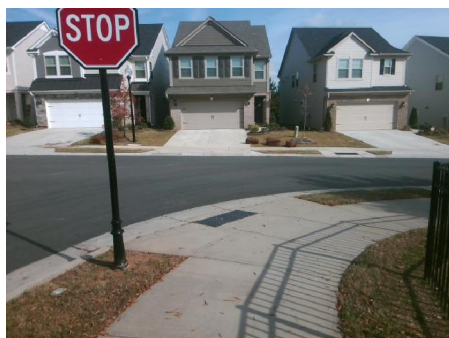
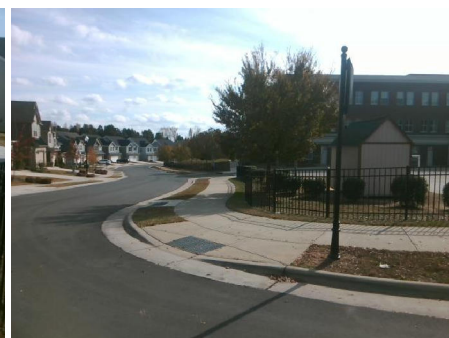
R304.2.2, R304.5.3

Compliance	Description	Data	Compliance	Description	Data
N/A	Ramp Length (in)	63.0	No	Ramp Slope (%)	10.6
Yes	Ramp Width (in)	48.0	No	Ramp XSlope (%)	6.7
N/A	Flare Type LT	N/A	N/A	Flare Type RT	N/A
N/A	Flare Slope LT (%)	N/A	N/A	Flare Slope RT (%)	N/A
N/A	Flare Traversable LT?	N/A	N/A	Flare Traversable RT?	N/A
N/A	Landing Length (in)	N/A	N/A	DWS Provided?	N/A
N/A	Landing Width (in)	N/A	N/A	DWS Contrast?	N/A
N/A	Landing Slope (%)	N/A	N/A	DWS Length (in)	N/A
N/A	Landing X Slope (%)	N/A	N/A	DWS Full Width?	N/A
N/A	Landing Curb? (Y/N)	N/A	N/A	DWS Offset (in)	N/A
N/A	Shared Landing?	N/A			
N/A	Gutter Ponding?	N/A	N/A	Gutter Slope (%)	N/A
N/A	Gutter Lip Ht (in)	N/A	N/A	Gutter X Slope (%)	N/A
N/A	Painted X Walk1?	No	N/A	Painted X Walk2?	N/A
	X Walk 1 Direction	To NW		X Walk 2 Direction	N/A
N/A	X Walk 1 Width (in)	N/A	N/A	X Walk 2 Width (in)	N/A
	X Walk 1 Slope (%)	4.6		X Walk 2 Slope (%)	N/A
	X Walk 1 X Slope (%)	0.5		X Walk 2 X Slope (%)	N/A

N/A	Ramp inside XWalk1?	N/A	N/A	Ramp inside XWalk2?	N/A
	Road Slope (%)	N/A	N/A	Clear Space?	N/A
	Road X Slope (%)	N/A	N/A	Clear Space to XWalk (in)	N/A
N/A	Any Obstructions?	N/A	N/A	Storm Grate/Utility Hazard?	N/A
	Obstruction Type			Storm Grate/Utility Type	
		N/A			N/A
			Yes	Surface Condition? (G/P)	Good

Possible Solutions:

Remove & Replace Entire Ramp.

Total Cost: \$ 1850.00
