Access Compliance Report Public Rights-of-Way (Curb Ramps)

Intersection ID: 11600Main Street: ALLEN_STCross Street: PARKWOOD_AVLocation: NWADA ID: C5D6BBCA6FEARamp Type: PerpInitial Pass/Fail: Fail Overall Compliance: No Severity Score: 8.75

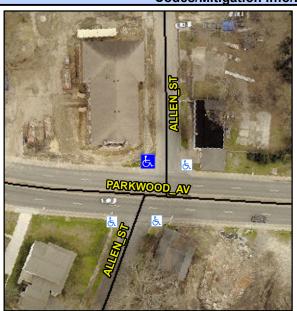
Compliance Description Dat		Data	Compliance Description			Data	
N/A	Ramp Length (in)	49.0	Yes	Ramp	Slope (%)	6.1	
No	Ramp Width (in)	47.5	Yes	Ramp	XSlope (%)	1.4	
N/A	Flare Type LT	N/A	N/A	Flare	Type RT	N/A	
N/A	Flare Slope LT (%)	N/A	N/A	Flare	Slope RT (%)	N/A	
N/A	Flare Traversable LT?	N/A	N/A	Flare	Traversable RT?	N/A	
N/A	Landing Length (in)	N/A	N/A	DWS	Provided?	N/A	
N/A	Landing Width (in)	N/A	N/A	DWS	Contrast?	N/A	
N/A	Landing Slope (%)	N/A	N/A	DWS	Length (in)	N/A	
N/A	Landing X Slope (%)	N/A	N/A	DWS	Full Width?	N/A	
N/A	Landing Curb? (Y/N)	N/A	N/A	DWS	Offset (in)	N/A	
N/A	Shared Landing?	N/A					
N/A	Gutter Ponding?	N/A	N/A	Gutte	r Slope (%)	N/A	
N/A	Gutter Lip Ht (in)	N/A	N/A	Gutte	r X Slope (%)	N/A	
N/A	Painted X Walk1?	No	N/A	Paint	ed X Walk2?	N/A	
	X Walk 1 Direction	To E		X Wa	lk 2 Direction	N/A	
N/A	X Walk 1 Width (in)	N/A	N/A	X Wa	lk 2 Width (in)	N/A	
	X Walk 1 Slope (%)	3.2		X Wa	lk 2 Slope (%)	N/A

X Walk 1 X Slope (%)	0.7		X Wa	lk 2 X Slope (%)	N/A	
N/A	Ramp inside XWalk1?	N/A	N/A	Ram	inside XWalk2?	N/A	
	Road Slope (%)	N/A	N/A	Clear	Space?	N/A	
	Road X Slope (%)	N/A	N/A	Clear	Space to XWalk (in)	N/A	
N/A	Any Obstructions?	N/A	N/A	Storn	n Grate/Utility Hazard?	N/A	
	Obstruction Type			Storn	n Grate/Utility Type		
		N/A				N/A	
			Yes	Surfa	ce Condition? (G/P)	Good

Possible Solution	
Possible Solutions:	Comp
Remove & Replace Entire Ramp.	N/A
	No
	N/A
	N/A
	N/A
	N/A
Surveyor Notes:	N/A
N/A	N/A
	N/A
	N/A
	N/A
PROW/ADA:	N/A
Not Found, R304.5.1	N/A
	N/A
	N/A
	N/A
