# Access Compliance Report

## Public Rights-of-Way

### (Curb Ramps)

| Intersection ID: 43350 | Main Street: FORESTRIDGE COMMONS DR | Cross Street: PROSPERITY COMMONS DR | Location: W |

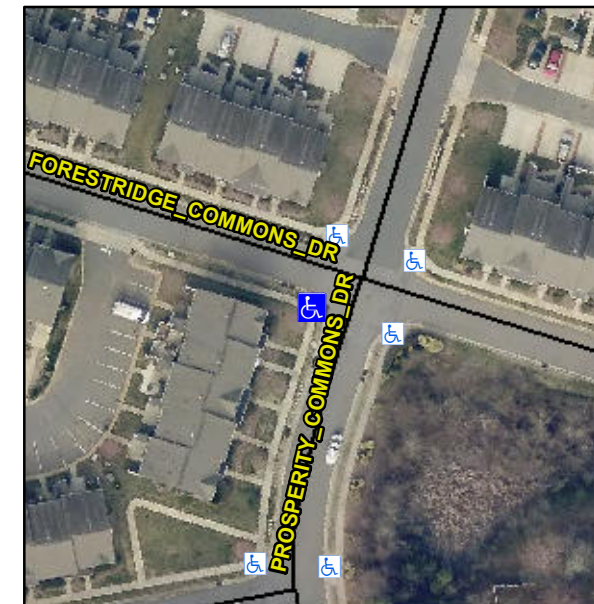
| ADA ID: C5DEFF69E5AA | Ramp Type: PerpDiag | Initial Pass/Fail: Fail | Overall Compliance: No |
| Severity Score: 22.5 | | | |

**R304.5.1, R304.2.2, R304.5.3**

| Compliance | Description | Data | Compliance | Description | Data |
|---|---|---|---|---|---|
| N/A | Ramp Length (in) | 46.0 | No | Ramp Slope (%) | 11.7 |
| No | Ramp Width (in) | 39.0 | No | Ramp XSlope (%) | 2.2 |

**Remove & Replace Curb Ramp With Two New Directional Ramps or Equivalent.**

Total Cost: \$ 3200.00
