Access Compliance Report

(Curb Ramps)

Intersection ID: 26114	Main Street: MCKEE_RD	Cross Street: PROVIDENCE_HILLS_DR	Location: S
ADA ID: C5EB69C51145	Ramp Type: Perp	Initial Pass/Fail: Fail	Overall Compliance: No
Severity Score: 22.5			
Codes/Mitigation Info/Possible Solution		Field Measurements/Component Compliance

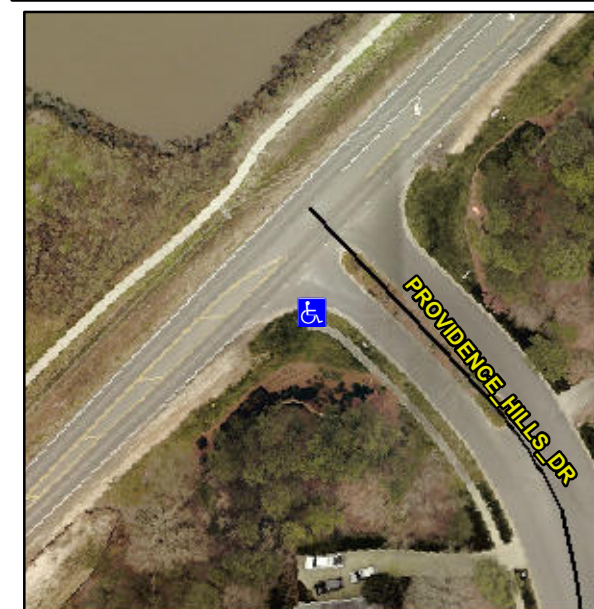
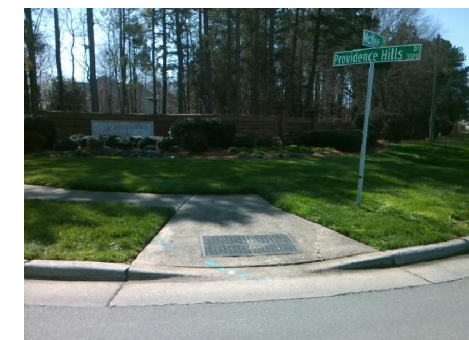
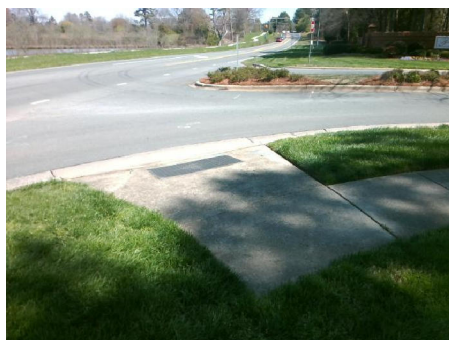
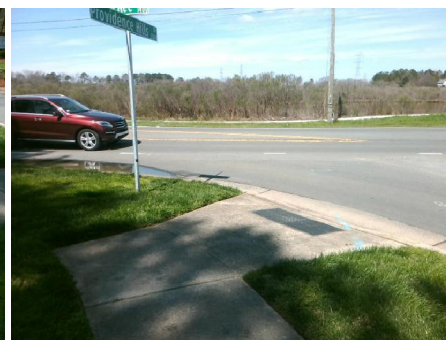
Not Found, R304.5.1, R304.2.2, R304.5.3

Compliance	Description	Data	Compliance	Description	Data
N/A	Ramp Length (in)	85.0	No	Ramp Slope (%)	11.3
No	Ramp Width (in)	43.0	No	Ramp XSlope (%)	3.2
N/A	Flare Type LT	N/A	N/A	Flare Type RT	N/A
N/A	Flare Slope LT (%)	N/A	N/A	Flare Slope RT (%)	N/A
N/A	Flare Traversable LT?	N/A	N/A	Flare Traversable RT?	N/A
N/A	Landing Length (in)	N/A	N/A	DWS Provided?	N/A
N/A	Landing Width (in)	N/A	N/A	DWS Contrast?	N/A
N/A	Landing Slope (%)	N/A	N/A	DWS Length (in)	N/A
N/A	Landing X Slope (%)	N/A	N/A	DWS Full Width?	N/A
N/A	Landing Curb? (Y/N)	N/A	N/A	DWS Offset (in)	N/A
N/A	Shared Landing?	N/A			
N/A	Gutter Ponding?	N/A	N/A	Gutter Slope (%)	N/A
N/A	Gutter Lip Ht (in)	N/A	N/A	Gutter X Slope (%)	N/A
N/A	Painted X Walk1?	No	N/A	Painted X Walk2?	N/A
	X Walk 1 Direction	To NE		X Walk 2 Direction	N/A
N/A	X Walk 1 Width (in)	N/A	N/A	X Walk 2 Width (in)	N/A
	X Walk 1 Slope (%)	0.3		X Walk 2 Slope (%)	N/A
	X Walk 1 X Slope (%)	2.0		X Walk 2 X Slope (%)	N/A

N/A	Ramp inside XWalk1?	N/A	N/A	Ramp inside XWalk2?	N/A
	Road Slope (%)	N/A	N/A	Clear Space?	N/A
	Road X Slope (%)	N/A	N/A	Clear Space to XWalk (in)	N/A
N/A	Any Obstructions?	N/A	N/A	Storm Grate/Utility Hazard?	N/A
	Obstruction Type			Storm Grate/Utility Type	
		N/A			N/A
			Yes	Surface Condition? (G/P)	Good

Possible Solutions:

Remove & Replace Entire Ramp.
