Access Compliance Report

Public Rights-of-Way

(Curb Ramps)

Intersection ID: 49932	Main Street: WOBURN_RD	Cross Street: PAXTON_RUN_RD	Location: SW
ADA ID: C5F4B78D67E9	Ramp Type: Perp	Initial Pass/Fail: Fail	Overall Compliance: No
Severity Score: 13.75			
Codes/Mitigation Info/Possible Solution		Field Measurements/Component Compliance

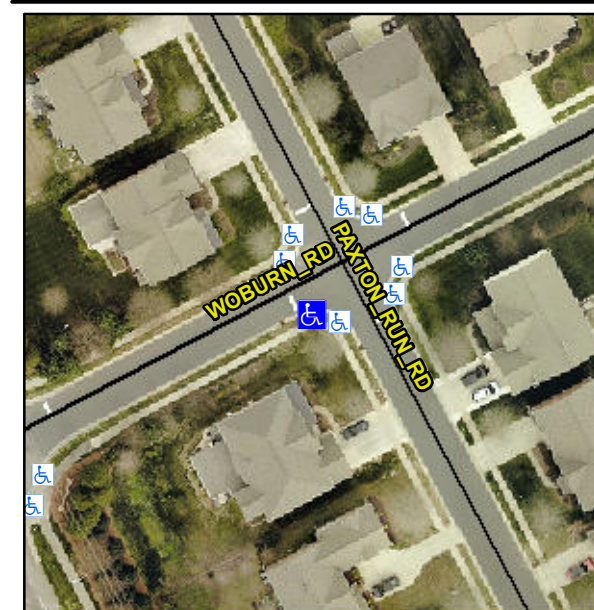
R304.2.2, R304.5.3

Compliance	Description	Data	Compliance	Description	Data
N/A	Ramp Length (in)	47.0	No	Ramp Slope (%)	8.5
Yes	Ramp Width (in)	48.0	No	Ramp XSlope (%)	3.3
N/A	Flare Type LT	N/A	N/A	Flare Type RT	N/A
N/A	Flare Slope LT (%)	N/A	N/A	Flare Slope RT (%)	N/A
N/A	Flare Traversable LT?	N/A	N/A	Flare Traversable RT?	N/A
N/A	Landing Length (in)	N/A	N/A	DWS Provided?	N/A
N/A	Landing Width (in)	N/A	N/A	DWS Contrast?	N/A
N/A	Landing Slope (%)	N/A	N/A	DWS Length (in)	N/A
N/A	Landing X Slope (%)	N/A	N/A	DWS Full Width?	N/A
N/A	Landing Curb? (Y/N)	N/A	N/A	DWS Offset (in)	N/A
N/A	Shared Landing?	N/A			
N/A	Gutter Ponding?	N/A	N/A	Gutter Slope (%)	N/A
N/A	Gutter Lip Ht (in)	N/A	N/A	Gutter X Slope (%)	N/A
N/A	Painted X Walk1?	No	N/A	Painted X Walk2?	N/A
	X Walk 1 Direction	To NE		X Walk 2 Direction	N/A
N/A	X Walk 1 Width (in)	N/A	N/A	X Walk 2 Width (in)	N/A
	X Walk 1 Slope (%)	3.6		X Walk 2 Slope (%)	N/A
	X Walk 1 X Slope (%)	1.6		X Walk 2 X Slope (%)	N/A

Possible Solutions:

Remove & Replace Entire Ramp.

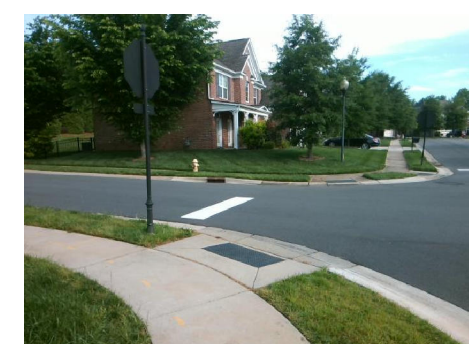
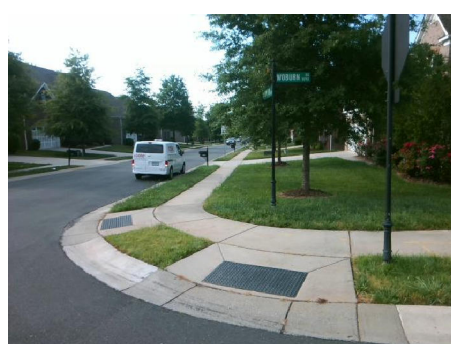
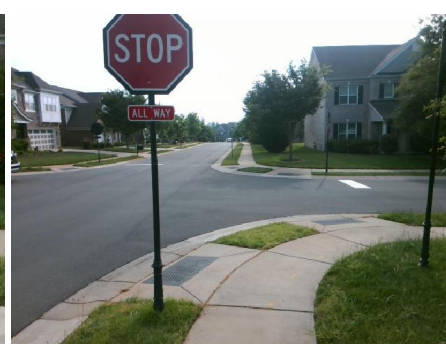
Street 1 Name **WOBURN RD**
 Stop Condition-Street 2 **StopSign**
 Street 2 Name **N/A**
 Stop Condition-Street 1 **N/A**
