# Access Compliance Report

## Public Rights-of-Way

### (Curb Ramps)

| Intersection ID: 46683 | Main Street: GOLDFIELDS_DR | Cross Street: ABODE_LILY_LN | Location: NE |

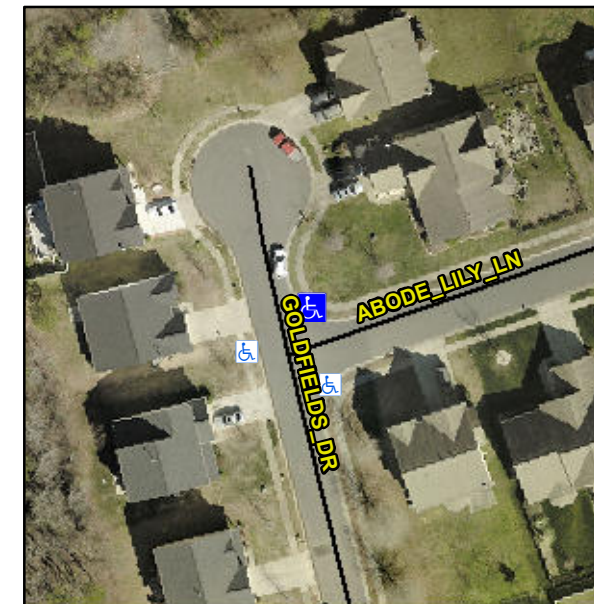
| Compliance | Description | Data | Compliance | Description | Data |
|---|---|---|---|---|---|
| No | Landing Length (in) | 47.0 | Yes | DWS Provided? | Yes |
| No | Landing Slope (%) | 3.0 | Yes | DWS Length (in) | 24.0 |
| N/A | Landing Curb? (Y/N) | No | No | DWS Offset (in) | 2.5 |

**Remove & Replace Curb Ramp With Two New Directional Ramps or Equivalent.**

**R304.2.1, R304.2.2-Perp, R304.3.2-Para, R305.2**
