Access Compliance Report

Public Rights-of-Way

(Curb Ramps)

Intersection ID: 54218	Main Street: GOLF_LINKS_DR	Cross Street: SANDY_ROCK_PL	Location: SE
ADA ID: C6037268D350	Ramp Type: Perp	Initial Pass/Fail: Fail	Overall Compliance: No
Severity Score: 12.5			
Codes/Mitigation Info/Possible Solution		Field Measurements/Component Compliance

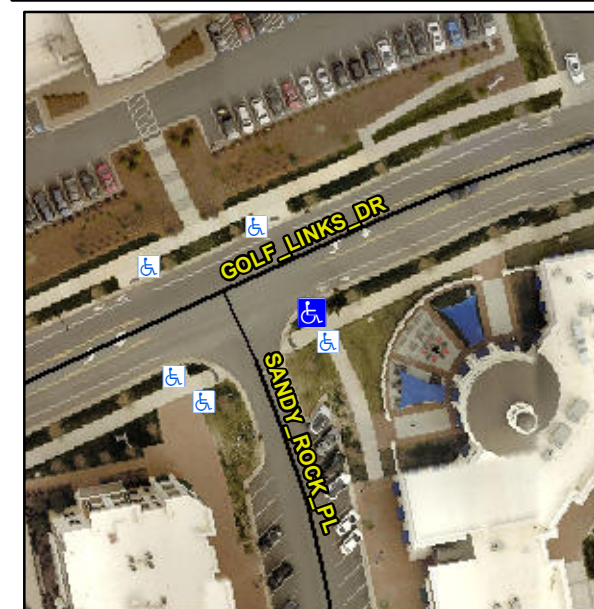
Not Found, R304.2.2

Compliance	Description	Data	Compliance	Description	Data
N/A	Ramp Length (in)	95.5	No	Ramp Slope (%)	8.9
Yes	Ramp Width (in)	94.0	Yes	Ramp XSlope (%)	0.3
N/A	Flare Type LT	N/A	N/A	Flare Type RT	N/A
N/A	Flare Slope LT (%)	N/A	N/A	Flare Slope RT (%)	N/A
N/A	Flare Traversable LT?	N/A	N/A	Flare Traversable RT?	N/A
N/A	Landing Length (in)	N/A	N/A	DWS Provided?	N/A
N/A	Landing Width (in)	N/A	N/A	DWS Contrast?	N/A
N/A	Landing Slope (%)	N/A	N/A	DWS Length (in)	N/A
N/A	Landing X Slope (%)	N/A	N/A	DWS Full Width?	N/A
N/A	Landing Curb? (Y/N)	N/A	N/A	DWS Offset (in)	N/A
N/A	Shared Landing?	N/A			
N/A	Gutter Ponding?	N/A	N/A	Gutter Slope (%)	N/A
N/A	Gutter Lip Ht (in)	N/A	N/A	Gutter X Slope (%)	N/A
N/A	Painted X Walk1?	No	N/A	Painted X Walk2?	N/A
	X Walk 1 Direction	To N		X Walk 2 Direction	N/A
N/A	X Walk 1 Width (in)	N/A	N/A	X Walk 2 Width (in)	N/A
	X Walk 1 Slope (%)	2.9		X Walk 2 Slope (%)	N/A
	X Walk 1 X Slope (%)	0.6		X Walk 2 X Slope (%)	N/A

N/A	Ramp inside XWalk1?	N/A	N/A	Ramp inside XWalk2?	N/A
	Road Slope (%)	N/A	N/A	Clear Space?	N/A
	Road X Slope (%)	N/A	N/A	Clear Space to XWalk (in)	N/A
N/A	Any Obstructions?	N/A	N/A	Storm Grate/Utility Hazard?	N/A
	Obstruction Type			Storm Grate/Utility Type	
		N/A			N/A
			Yes	Surface Condition? (G/P)	Good

Remove & Replace Entire Ramp.
