Access Compliance Report

Public Rights-of-Way

(Curb Ramps)

Intersection ID: 4839	Main Street: TRINITY_RD	Cross Street: BEATTIES_FORD_RD	Location: NE
ADA ID: C61519822AC3	Ramp Type: Perp	Initial Pass/Fail: Fail	Overall Compliance: No
		Severity Score: 8.75

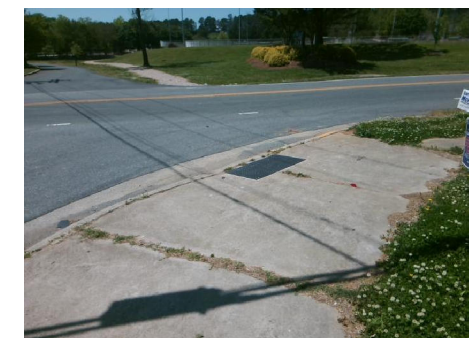
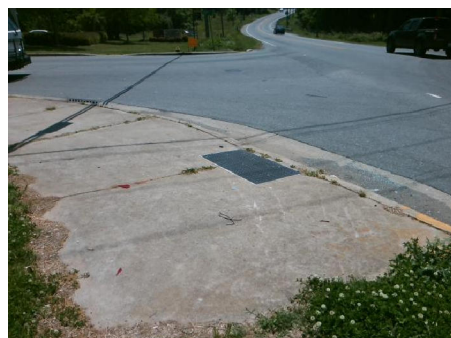
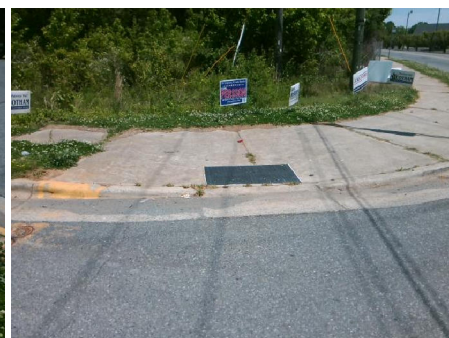
Compliance	Description	Data	Compliance	Description	Data
N/A	Ramp Length (in)	106.5	Yes	Ramp Slope (%)	7.9
No	Ramp Width (in)	46.0	Yes	Ramp XSlope (%)	1.1
N/A	Flare Type LT	N/A	N/A	Flare Type RT	N/A
N/A	Flare Slope LT (%)	N/A	N/A	Flare Slope RT (%)	N/A
N/A	Flare Traversable LT?	N/A	N/A	Flare Traversable RT?	N/A
N/A	Landing Length (in)	N/A	N/A	DWS Provided?	N/A
N/A	Landing Width (in)	N/A	N/A	DWS Contrast?	N/A
N/A	Landing Slope (%)	N/A	N/A	DWS Length (in)	N/A
N/A	Landing X Slope (%)	N/A	N/A	DWS Full Width?	N/A
N/A	Landing Curb? (Y/N)	N/A	N/A	DWS Offset (in)	N/A
N/A	Shared Landing?	N/A			
N/A	Gutter Ponding?	N/A	N/A	Gutter Slope (%)	N/A
N/A	Gutter Lip Ht (in)	N/A	N/A	Gutter X Slope (%)	N/A
N/A	Painted X Walk1?	No	N/A	Painted X Walk2?	N/A
	X Walk 1 Direction	To W		X Walk 2 Direction	N/A
N/A	X Walk 1 Width (in)	N/A	N/A	X Walk 2 Width (in)	N/A
	X Walk 1 Slope (%)	1.8		X Walk 2 Slope (%)	N/A
	X Walk 1 X Slope (%)	3.1		X Walk 2 X Slope (%)	N/A

N/A	Ramp inside XWalk1?	N/A	N/A	Ramp inside XWalk2?	N/A
	Road Slope (%)	3.1	N/A	Clear Space?	N/A
	Road X Slope (%)	1.8	N/A	Clear Space to XWalk (in)	N/A
N/A	Any Obstructions?	N/A	N/A	Storm Grate/Utility Hazard?	N/A
	Obstruction Type			Storm Grate/Utility Type	
		N/A			N/A
			Yes	Surface Condition? (G/P)	Good

Remove & Replace Entire Ramp.
