Access Compliance Report

Public Rights-of-Way

(Curb Ramps)

Intersection ID: 29928	Main Street: BEARD_RD	Cross Street: CAROLINA_LILY_LN	Location: SE
ADA ID: C626CDAF8092	Ramp Type: BlendTrans1	Initial Pass/Fail: Fail	Overall Compliance: No
		Severity Score: 10

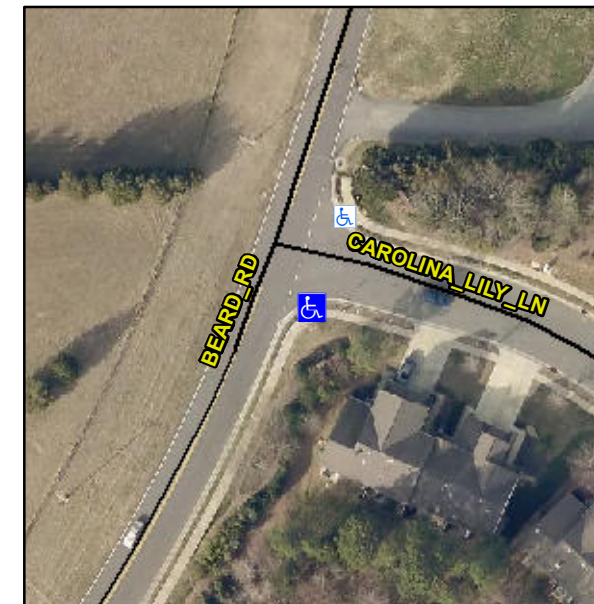
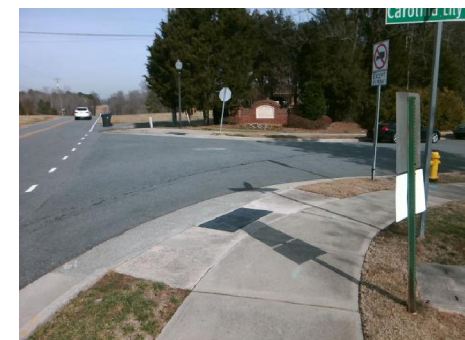
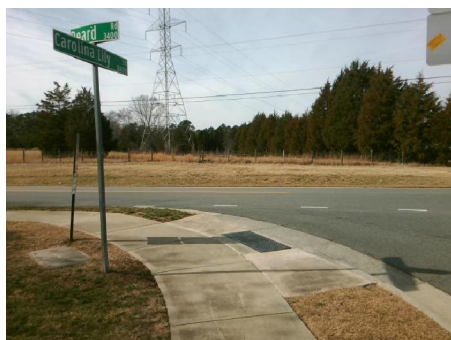
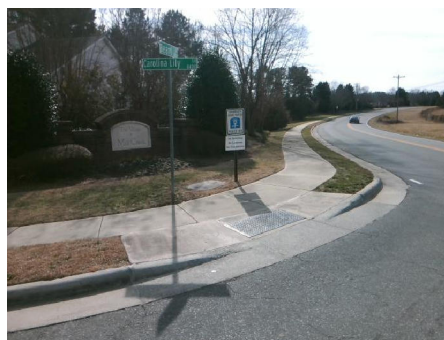
Compliance	Description	Data	Compliance	Description	Data
N/A	Ramp Length (in)	37.0	Yes	BlendTrans Slope (%)	3.5
No	Ramp Width (in)	43.0	No	BlendTrans XSlope (%)	4.4
N/A	Flare Type LT	N/A	N/A	Flare Type RT	N/A
N/A	Flare Slope LT (%)	N/A	N/A	Flare Slope RT (%)	N/A
N/A	Flare Traversable LT?	N/A	N/A	Flare Traversable RT?	N/A
N/A	Landing Length (in)	N/A	N/A	DWS Provided?	N/A
N/A	Landing Width (in)	N/A	N/A	DWS Contrast?	N/A
N/A	Landing Slope (%)	N/A	N/A	DWS Length (in)	N/A
N/A	Landing X Slope (%)	N/A	N/A	DWS Full Width?	N/A
N/A	Landing Curb? (Y/N)	N/A	N/A	DWS Offset (in)	N/A
N/A	Shared Landing?	N/A			
N/A	Gutter Ponding?	N/A	N/A	Gutter Slope (%)	N/A
N/A	Gutter Lip Ht (in)	N/A	N/A	Gutter X Slope (%)	N/A
N/A	Painted X Walk1?	No	N/A	Painted X Walk2?	N/A
	X Walk 1 Direction	To NE		X Walk 2 Direction	N/A
	X Walk 1 Width (in)	N/A		X Walk 2 Width (in)	N/A
	X Walk 1 Slope (%)	0.8		X Walk 2 Slope (%)	N/A
	X Walk 1 X Slope (%)	2.3		X Walk 2 X Slope (%)	N/A

N/A	Ramp inside XWalk1?	N/A	N/A	Ramp inside XWalk2?	N/A
	Road Slope (%)	2.3		Clear Space?	N/A
	Road X Slope (%)	0.8	N/A	Clear Space to XWalk (in)	N/A
N/A	Any Obstructions?	N/A	N/A	Storm Grate/Utility Hazard?	N/A
	Obstruction Type			Storm Grate/Utility Type	
		N/A			N/A
			Yes	Surface Condition? (G/P)	Good
			N/A	Curb Slope (%)	2.2

Remove & Replace Curb Ramp With Two New Directional Ramps or Equivalent.

R304.5.1, R304.5.3
