# Access Compliance Report

## Public Rights-of-Way

### (Curb Ramps)

| Intersection ID: 26515 | Main Street: JOHNSTON_RD | Cross Street: PORTERFIELD_RD | Location: NE |

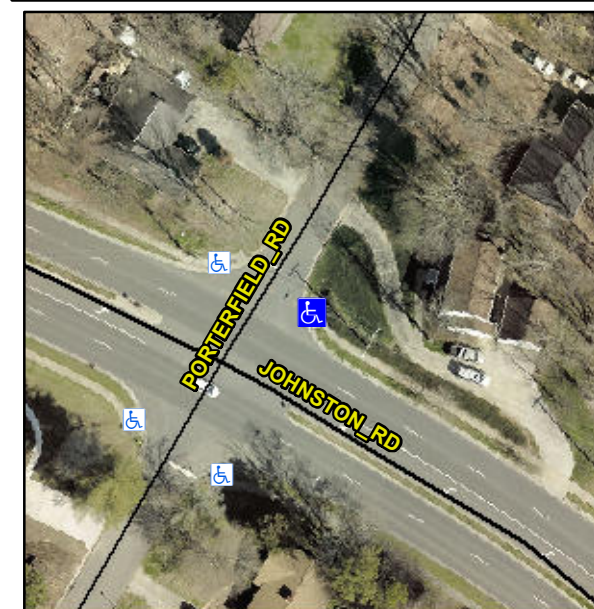
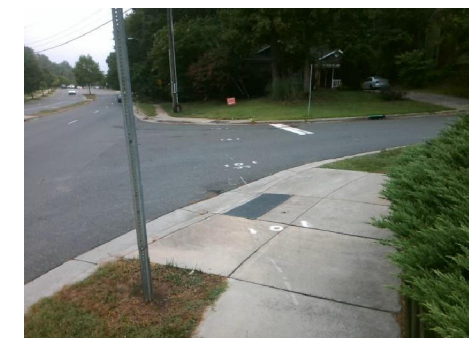
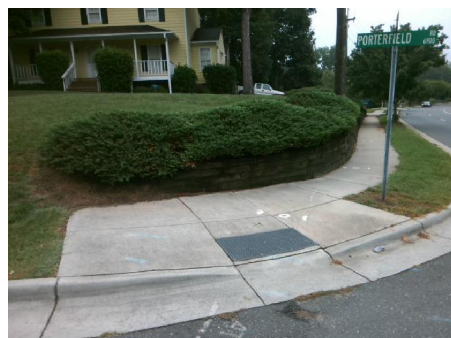
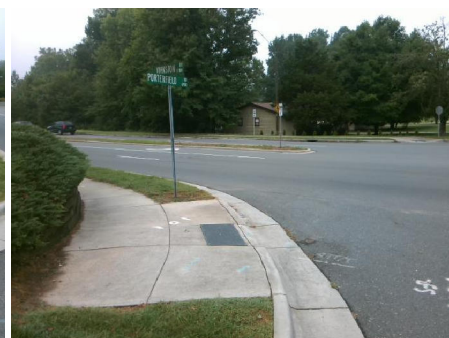
| ADA ID: C627B31E8C99 | Ramp Type: PerpDiag | Initial Pass/Fail: Fail | Overall Compliance: No |

**Not Found, R304.5.1, R304.2.2, R304.5.3**

| Compliance | Description | Data | Compliance | Description | Data |
|---|---|---|---|---|---|
| N/A | Ramp Length (in) | 49.0 | No | Ramp Slope (%) | 9.7 |
| No | Ramp Width (in) | 45.0 | No | Ramp XSlope (%) | 7.3 |

**Remove & Replace Curb Ramp With Two New Directional Ramps or Equivalent.**
