Access Compliance Report

Public Rights-of-Way

(Curb Ramps)

Intersection ID: 25342	Main Street: MCPHERSON_DR	Cross Street: WYCOMBE_CT	Location: SW
ADA ID: C62DCAD6CCCE	Ramp Type: Directional1	Initial Pass/Fail: Fail	Overall Compliance: No
		Severity Score: 10

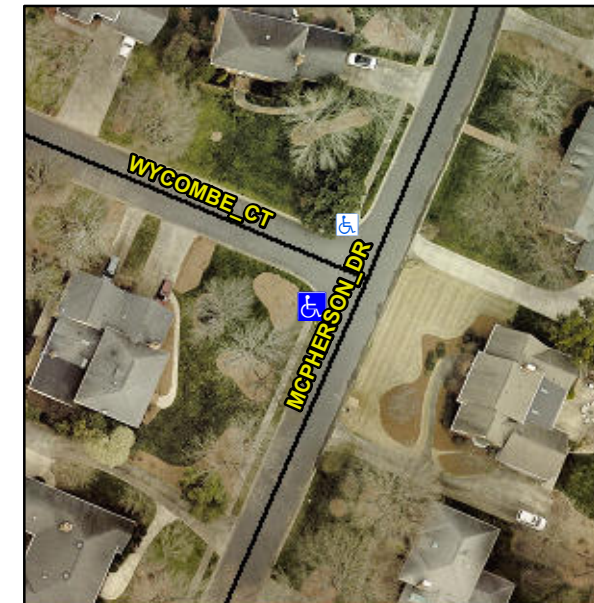
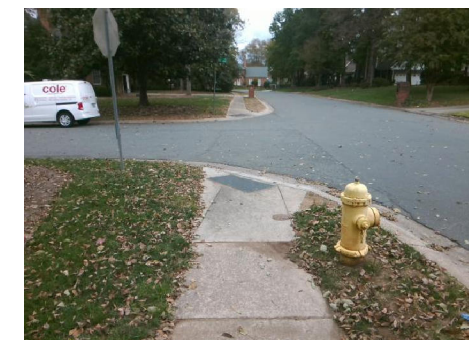
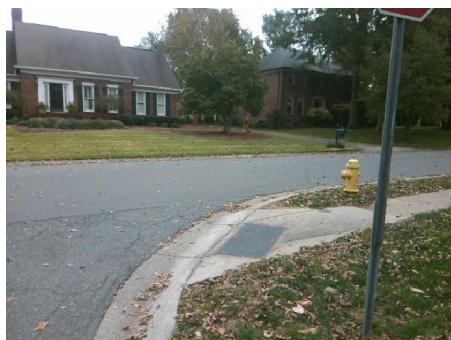
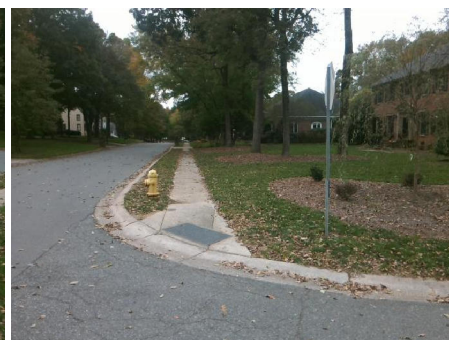
R304.5.1, R304.5.3

Compliance	Description	Data	Compliance	Description	Data
N/A	Ramp Length (in)	108.0	N/A	Grade Break?	N/A
No	Ramp Width (in)	39.0	N/A	Grade Break Slope (%)	0.0
Yes	Ramp Slope (%)	5.1	N/A	Grade Break XSlope (%)	0.0
No	Ramp XSlope (%)	4.3			
N/A	Flare Type LT	N/A	N/A	Flare Type RT	N/A
N/A	Flare Slope LT (%)	N/A	N/A	Flare Slope RT (%)	0.0
N/A	Flare Traversable LT?	N/A	N/A	Flare Traversable RT?	N/A
N/A	Landing Length (in)	0.0	N/A	DWS Provided?	N/A
N/A	Landing Width (in)	0.0	N/A	DWS Contrast?	N/A
N/A	Landing Slope (%)	0.0	N/A	DWS Length (in)	N/A
N/A	Landing X Slope (%)	0.0	N/A	DWS Full Width?	N/A
N/A	Landing Curb? (Y/N)	N/A	N/A	DWS Offset LT (in)	N/A
N/A	Shared Landing?	N/A	N/A	DWS Offset RT (in)	N/A
N/A	Gutter Ponding?	0.0	N/A	Gutter Slope (%)	N/A
N/A	Gutter Lip Ht (in)	0.0	N/A	Gutter X Slope (%)	N/A
N/A	Painted X Walk1?	No		Road Slope (%)	1.8
	X Walk 1 Direction	To NE		Road X Slope (%)	5.7
	X Walk 1 Width (in)	N/A		Clear Space?	N/A

X Walk 1 Slope (%)	1.8	N/A	Clear Space to XWalk (in)	N/A
	X Walk 1 X Slope (%)	5.7	N/A	Storm Grate/Utility Hazard?	N/A
N/A	Ramp inside XWalk1?	N/A		Storm Grate/Utility Type	
N/A	Any Obstructions?	N/A			N/A
	Obstruction Type		Yes	Surface Condition? (G/P)	Good
			N/A	Curb Slope (%)	11.4

Remove & Replace Entire Ramp.
