Access Compliance Report

Public Rights-of-Way

(Curb Ramps)

Intersection ID: 21728	Main Street: BRYNHURST_DR	Cross Street: WATERCREST_RD	Location: NW
ADA ID: C6373F1AB453	Ramp Type: PerpDiag	Initial Pass/Fail: Fail	Overall Compliance: No
Severity Score: 12.5			
Codes/Mitigation Info/Possible Solution		Field Measurements/Component Compliance

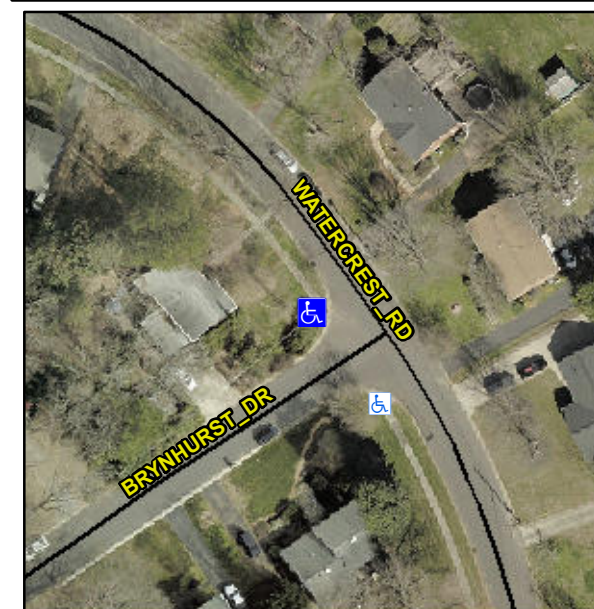
Not Found, R304.2.2

Compliance	Description	Data	Compliance	Description	Data
N/A	Ramp Length (in)	56.0	No	Ramp Slope (%)	8.7
Yes	Ramp Width (in)	48.0	Yes	Ramp XSlope (%)	1.1
N/A	Flare Type LT	N/A	N/A	Flare Type RT	N/A
N/A	Flare Slope LT (%)	N/A	N/A	Flare Slope RT (%)	N/A
N/A	Flare Traversable LT?	N/A	N/A	Flare Traversable RT?	N/A
N/A	Landing Length (in)	N/A	N/A	DWS Provided?	N/A
N/A	Landing Width (in)	N/A	N/A	DWS Contrast?	N/A
N/A	Landing Slope (%)	N/A	N/A	DWS Length (in)	N/A
N/A	Landing X Slope (%)	N/A	N/A	DWS Full Width?	N/A
N/A	Landing Curb? (Y/N)	N/A	N/A	DWS Offset (in)	N/A
N/A	Shared Landing?	N/A			
N/A	Gutter Ponding?	N/A	N/A	Gutter Slope (%)	N/A
N/A	Gutter Lip Ht (in)	N/A	N/A	Gutter X Slope (%)	N/A
N/A	Painted X Walk1?	No	N/A	Painted X Walk2?	No
	X Walk 1 Direction	To SE		X Walk 2 Direction	To NE
N/A	X Walk 1 Width (in)	N/A	N/A	X Walk 2 Width (in)	N/A
	X Walk 1 Slope (%)	1.5		X Walk 2 Slope (%)	3.4
	X Walk 1 X Slope (%)	2.2		X Walk 2 X Slope (%)	3.5

N/A	Ramp inside XWalk1?	N/A	N/A	Ramp inside XWalk2?	N/A
	Road Slope (%)	2.8	N/A	Clear Space?	N/A
	Road X Slope (%)	0.0	N/A	Clear Space to XWalk (in)	N/A
N/A	Any Obstructions?	N/A	N/A	Storm Grate/Utility Hazard?	N/A
	Obstruction Type			Storm Grate/Utility Type	
		N/A			N/A
			Yes	Surface Condition? (G/P)	Good

Remove & Replace Curb Ramp With Two New Directional Ramps or Equivalent.

Total Cost: \$ 3200.00
