Access Compliance Report

Public Rights-of-Way

(Curb Ramps)

Intersection ID: 30303	Main Street: HAVEN_CROSS_LN	Cross Street: MUMFORD_LN	Location: SW
ADA ID: C63C9EC6A54A	Ramp Type: PerpDiag	Initial Pass/Fail: Fail	Overall Compliance: No
Severity Score: 13.75			
Codes/Mitigation Info/Possible Solution		Field Measurements/Component Compliance

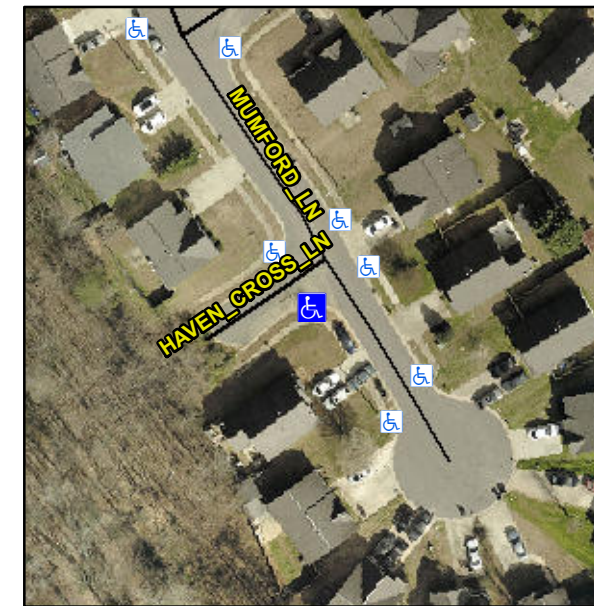
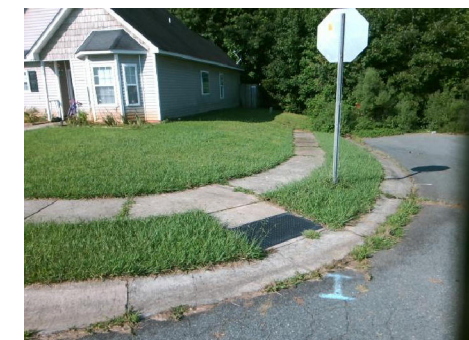
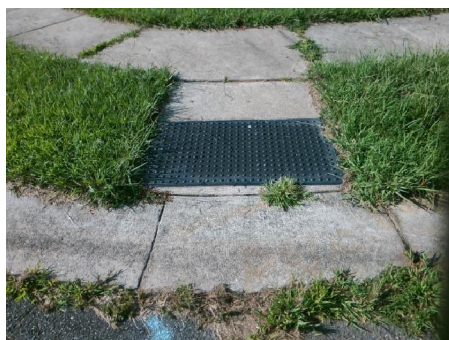
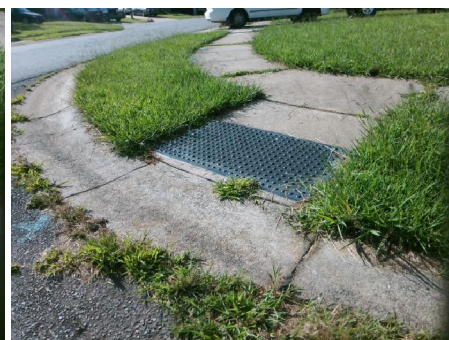
Not Found, R304.2.2, R304.5.3

Compliance	Description	Data	Compliance	Description	Data
N/A	Ramp Length (in)	48.5	No	Ramp Slope (%)	10.4
Yes	Ramp Width (in)	48.0	No	Ramp XSlope (%)	4.0
N/A	Flare Type LT	N/A	N/A	Flare Type RT	N/A
N/A	Flare Slope LT (%)	N/A	N/A	Flare Slope RT (%)	N/A
N/A	Flare Traversable LT?	N/A	N/A	Flare Traversable RT?	N/A
N/A	Landing Length (in)	N/A	N/A	DWS Provided?	N/A
N/A	Landing Width (in)	N/A	N/A	DWS Contrast?	N/A
N/A	Landing Slope (%)	N/A	N/A	DWS Length (in)	N/A
N/A	Landing X Slope (%)	N/A	N/A	DWS Full Width?	N/A
N/A	Landing Curb? (Y/N)	N/A	N/A	DWS Offset (in)	N/A
N/A	Shared Landing?	N/A			
N/A	Gutter Ponding?	N/A	N/A	Gutter Slope (%)	N/A
N/A	Gutter Lip Ht (in)	N/A	N/A	Gutter X Slope (%)	N/A
N/A	Painted X Walk1?	No	N/A	Painted X Walk2?	No
	X Walk 1 Direction	To NE		X Walk 2 Direction	To NW
N/A	X Walk 1 Width (in)	N/A	N/A	X Walk 2 Width (in)	N/A
	X Walk 1 Slope (%)	2.7		X Walk 2 Slope (%)	1.2
	X Walk 1 X Slope (%)	1.4		X Walk 2 X Slope (%)	0.3

N/A	Ramp inside XWalk1?	N/A	N/A	Ramp inside XWalk2?	N/A
	Road Slope (%)	4.7	N/A	Clear Space?	N/A
	Road X Slope (%)	2.0	N/A	Clear Space to XWalk (in)	N/A
N/A	Any Obstructions?	N/A	N/A	Storm Grate/Utility Hazard?	N/A
	Obstruction Type			Storm Grate/Utility Type	
		N/A			N/A
			Yes	Surface Condition? (G/P)	Good

Possible Solutions:

Remove & Replace Curb Ramp With Two New Directional Ramps or Equivalent.
