Access Compliance Report

Public Rights-of-Way (Curb Ramps)

Intersection ID: 52530	Main Street: BAMBOO_ST	Cross Street: PIERSON_DR	Location:	N
ADA ID: C640B0618E63	Ramp Type: Perp	Initial Pass/Fail: Fail	Overall Compliance: No	Severity Score: 13.75

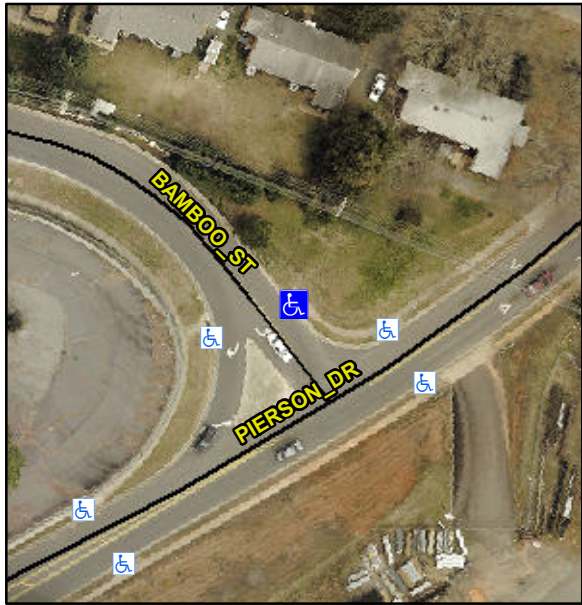
Possible Solutions:		Remove & Replace Entire Ramp.					
	Surveyor Notes:		N/A					
	PROW/ADA:		Not Found, R304.2.2, R304.5.3					
	Total Cost:		\$ 1850.00					
	Street 1 Name		BAMBOO ST					
	Stop Condition-Street 2		None					
	Street 2 Name		N/A					
	Stop Condition-Street 1		N/A					
			Compliance	Description	Data	Compliance	Description	Data
			N/A	Ramp Length (in)	85.0	No	Ramp Slope (%)	8.8
			Yes	Ramp Width (in)	64.5	No	Ramp XSlope (%)	3.6
			N/A	Flare Type LT	N/A	N/A	Flare Type RT	N/A
			N/A	Flare Slope LT (%)	N/A	N/A	Flare Slope RT (%)	N/A
			N/A	Flare Traversable LT?	N/A	N/A	Flare Traversable RT?	N/A
			N/A	Landing Length (in)	N/A	N/A	DWS Provided?	N/A
			N/A	Landing Width (in)	N/A	N/A	DWS Contrast?	N/A
			N/A	Landing Slope (%)	N/A	N/A	DWS Length (in)	N/A
			N/A	Landing X Slope (%)	N/A	N/A	DWS Full Width?	N/A
			N/A	Landing Curb? (Y/N)	N/A	N/A	DWS Offset (in)	N/A

N/A	Shared Landing?	N/A			
			N/A	Gutter Ponding?	N/A	N/A	Gutter Slope (%)	N/A
			N/A	Gutter Lip Ht (in)	N/A	N/A	Gutter X Slope (%)	N/A
			N/A	Painted X Walk1?	No	N/A	Painted X Walk2?	N/A
				X Walk 1 Direction	To W		X Walk 2 Direction	N/A
			N/A	X Walk 1 Width (in)	N/A	N/A	X Walk 2 Width (in)	N/A
				X Walk 1 Slope (%)	1.0		X Walk 2 Slope (%)	N/A
				X Walk 1 X Slope (%)	3.5		X Walk 2 X Slope (%)	N/A
			N/A	Ramp inside XWalk1?	N/A	N/A	Ramp inside XWalk2?	N/A
				Road Slope (%)	N/A	N/A	Clear Space?	N/A
				Road X Slope (%)	N/A	N/A	Clear Space to XWalk (in)	N/A
			N/A	Any Obstructions?	N/A	N/A	Storm Grate/Utility Hazard?	N/A
				Obstruction Type			Storm Grate/Utility Type	
					N/A			N/A
						Yes	Surface Condition? (G/P)	Good
