# Access Compliance Report

## Public Rights-of-Way

### (Curb Ramps)

| Intersection ID: N/A | Main Street: PARKWAY_PLAZA_BV | Cross Street: COURTNEY_COMMONS_LN | Location: SE |

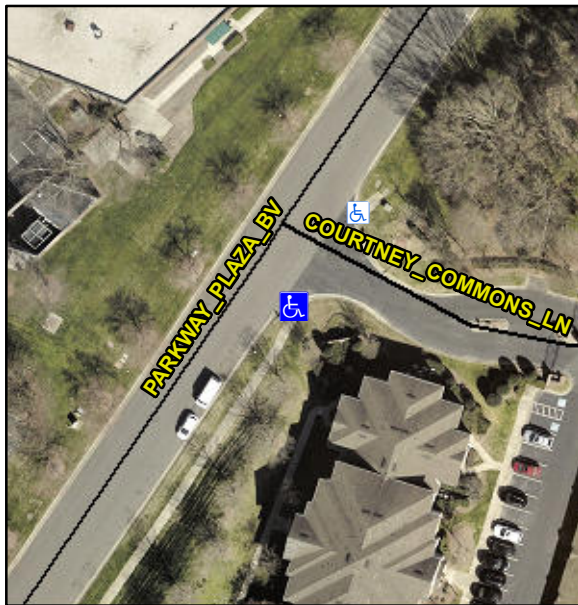
| ADA ID: C6410F2AB1C8 | Ramp Type: Directional1 | Initial Pass/Fail: Fail | Overall Compliance: No |
| Severity Score: 33.75 | | | |

**R304.5.1, R304.5.3**

| Compliance | Description | Data | Compliance | Description | Data |
|---|---|---|---|---|---|
| No | Ramp Width (in) | 43.0 | N/A | Grade Break Slope (%) | 0.0 |
| No | Ramp XSlope (%) | 8.0 | | | |

**Remove & Replace Entire Ramp.**
