# Access Compliance Report

## Public Rights-of-Way

### (Curb Ramps)

Intersection ID: N/A	Main Street: S BREVARD ST	Cross Street: E 4TH ST	Location: N
ADA ID: C66B080B612B	Ramp Type: Perp	Initial Pass/Fail: Fail	Overall Compliance: No
Severity Score: 13.75			
Codes/Mitigation Info/Possible Solution		Field Measurements/Component Compliance

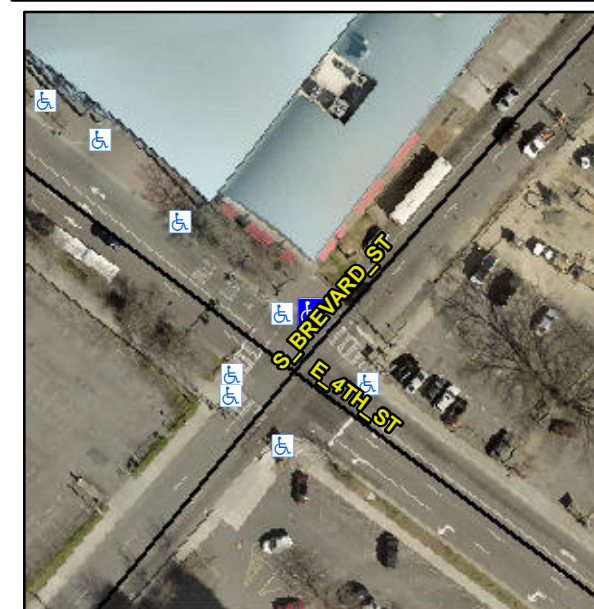
**Not Found, R304.2.2**

Compliance	Description	Data	Compliance	Description	Data
N/A	Ramp Length (in)	24.0	No	Ramp Slope (%)	9.9
Yes	Ramp Width (in)	51.0	Yes	Ramp XSlope (%)	2.5
N/A	Flare Type LT	N/A	N/A	Flare Type RT	N/A
N/A	Flare Slope LT (%)	N/A	N/A	Flare Slope RT (%)	N/A
N/A	Flare Traversable LT?	No	N/A	Flare Traversable RT?	No
N/A	Landing Length (in)	N/A	N/A	DWS Provided?	N/A
N/A	Landing Width (in)	N/A	N/A	DWS Contrast?	N/A
N/A	Landing Slope (%)	N/A	N/A	DWS Length (in)	N/A
N/A	Landing X Slope (%)	N/A	N/A	DWS Full Width?	N/A
N/A	Landing Curb? (Y/N)	N/A	N/A	DWS Offset (in)	N/A
N/A	Shared Landing?	N/A			
N/A	Gutter Ponding?	N/A	N/A	Gutter Slope (%)	N/A
N/A	Gutter Lip Ht (in)	N/A	N/A	Gutter X Slope (%)	N/A
N/A	Painted X Walk1?	Yes	N/A	Painted X Walk2?	N/A
	X Walk 1 Direction	To SE		X Walk 2 Direction	N/A
N/A	X Walk 1 Width (in)	115.0	N/A	X Walk 2 Width (in)	N/A
	X Walk 1 Slope (%)	1.9		X Walk 2 Slope (%)	N/A
	X Walk 1 X Slope (%)	4.0		X Walk 2 X Slope (%)	N/A

N/A	Ramp inside XWalk1?	Yes	N/A	Ramp inside XWalk2?	N/A
	Road Slope (%)	N/A	N/A	Clear Space?	N/A
	Road X Slope (%)	N/A	N/A	Clear Space to XWalk (in)	N/A
N/A	Any Obstructions?	N/A	N/A	Storm Grate/Utility Hazard?	N/A
	Obstruction Type			Storm Grate/Utility Type	
		N/A			N/A
			Yes	Surface Condition? (G/P)	Good

**Remove & Replace Entire Ramp.**

Total Cost: \$ 1850.00
