Access Compliance Report Public Rights-of-Way (Curb Ramps)

Intersection ID: 5741 Main Street: MALLARD_CREEK_RD Cross Street: NEVIN_RD Location: N

ADA ID: C6752FA59F83 Ramp Type: Perp Initial Pass/Fail: Fail Overall Compliance: No Severity Score: 8.75

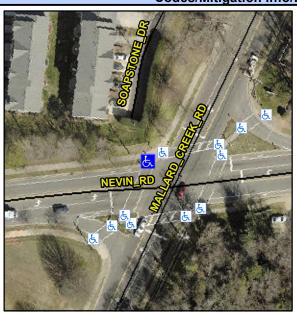
Field Measurements/Component Compliance							
Compl	liance Description	Data	Comp	liance	Description	Data	
N/A	Ramp Length (in)	60.0	Yes	Ramp	Slope (%)	5.2	
No	Ramp Width (in)	47.5	Yes	Ramp	XSlope (%)	1.9	
N/A	Flare Type LT	N/A	N/A	Flare	Type RT	N/A	
N/A	Flare Slope LT (%)	N/A	N/A	Flare	Slope RT (%)	N/A	
N/A	Flare Traversable LT?	N/A	N/A	Flare	Traversable RT?	N/A	
N/A	Landing Length (in)	N/A	N/A	DWS	Provided?	N/A	
N/A	Landing Width (in)	N/A	N/A	DWS	Contrast?	N/A	
N/A	Landing Slope (%)	N/A	N/A	DWS	Length (in)	N/A	
N/A	Landing X Slope (%)	N/A	N/A	DWS	Full Width?	N/A	
N/A	Landing Curb? (Y/N)	N/A	N/A	DWS	Offset (in)	N/A	
N/A	Shared Landing?	N/A					
N/A	Gutter Ponding?	N/A	N/A	Gutte	r Slope (%)	N/A	
N/A	Gutter Lip Ht (in)	N/A	N/A	Gutte	r X Slope (%)	N/A	
N/A	Painted X Walk1?	Yes	N/A	Paint	ed X Walk2?	N/A	
	X Walk 1 Direction	To SW		X Wa	lk 2 Direction	N/A	
N/A	X Walk 1 Width (in)	120.0	N/A	X Wa	lk 2 Width (in)	N/A

X Walk 1 Slope (%)	0.9		X Wa	lk 2 Slope (%)	N/A	
	X Walk 1 X Slope (%)	1.2		X Wa	lk 2 X Slope (%)	N/A	
N/A	Ramp inside XWalk1?	Yes	N/A	Ramp	inside XWalk2?	N/A	
	Road Slope (%)	N/A	N/A	Clear	Space?	N/A	
	Road X Slope (%)	N/A	N/A	Clear	Space to XWalk (in)	N/A	
N/A	Any Obstructions?	N/A	N/A	Storm	n Grate/Utility Hazard?	N/A	
	Obstruction Type			Storm	Grate/Utility Type		
		N/A				N/A	
			Yes	Surfa	ce Condition? (G/P)	Good

1 CCCIBIC CCIGNON	
Possible Solutions:	Con
Remove & Replace Entire Ramp.	N/A
•	No
	N/A
	N/A
	N/A
	N/A
Surveyor Notes:	N/A
N/A	N/A
	N/A
	N/A
	N/A
PROW/ADA:	N/A
Not Found, R304.5.1	N/A
•	N/A
	N/A
	N/A
