Access Compliance Report

Public Rights-of-Way

(Curb Ramps)

Intersection ID: 12242	Main Street: S_CEDAR_ST	Cross Street: MORRIS_ST	Location: SW
ADA ID: C676C334411F	Ramp Type: Directional1	Initial Pass/Fail: Fail	Overall Compliance: No
Severity Score: 37.5			
Codes/Mitigation Info/Possible Solution		Field Measurements/Component Compliance

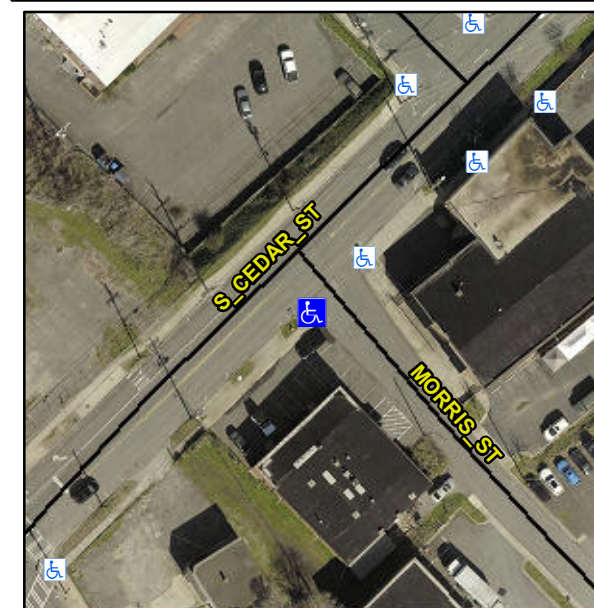
Compliance	Description	Data	Compliance	Description	Data
N/A	Ramp Length (in)	94.0	N/A	Grade Break?	N/A
Yes	Ramp Width (in)	60.0	N/A	Grade Break Slope (%)	0.0
No	Ramp Slope (%)	12.0	N/A	Grade Break XSlope (%)	0.0
No	Ramp XSlope (%)	5.9			
N/A	Flare Type LT	N/A	N/A	Flare Type RT	N/A
N/A	Flare Slope LT (%)	N/A	N/A	Flare Slope RT (%)	0.0
N/A	Flare Traversable LT?	N/A	N/A	Flare Traversable RT?	N/A
N/A	Landing Length (in)	0.0	N/A	DWS Provided?	N/A
N/A	Landing Width (in)	0.0	N/A	DWS Contrast?	N/A
N/A	Landing Slope (%)	0.0	N/A	DWS Length (in)	N/A
N/A	Landing X Slope (%)	0.0	N/A	DWS Full Width?	N/A
N/A	Landing Curb? (Y/N)	N/A	N/A	DWS Offset LT (in)	N/A
N/A	Shared Landing?	N/A	N/A	DWS Offset RT (in)	N/A
N/A	Gutter Ponding?	0.0	N/A	Gutter Slope (%)	N/A
N/A	Gutter Lip Ht (in)	0.0	N/A	Gutter X Slope (%)	N/A
N/A	Painted X Walk1?	No		Road Slope (%)	2.2
	X Walk 1 Direction	To NE		Road X Slope (%)	4.0
	X Walk 1 Width (in)	N/A		Clear Space?	N/A

X Walk 1 Slope (%)	2.2	N/A	Clear Space to XWalk (in)	N/A
	X Walk 1 X Slope (%)	4.0	N/A	Storm Grate/Utility Hazard?	N/A
N/A	Ramp inside XWalk1?	N/A		Storm Grate/Utility Type	
N/A	Any Obstructions?	N/A			N/A
	Obstruction Type		Yes	Surface Condition? (G/P)	Good
			N/A	Curb Slope (%)	12.0

Possible Solutions:

Remove & Replace Entire Ramp.

PROW/ADA:

R304.2.2, R304.5.3
