Access Compliance Report

Public Rights-of-Way

(Curb Ramps)

Intersection ID: N/A	Main Street: STEEL_CREEK_RD	Cross Street: ENTRANCE_DR	Location: E
ADA ID: C6786286B8CD	Ramp Type: BlendTrans2	Initial Pass/Fail: Fail	Overall Compliance: No
Severity Score: 21.25			
Codes/Mitigation Info/Possible Solution		Field Measurements/Component Compliance

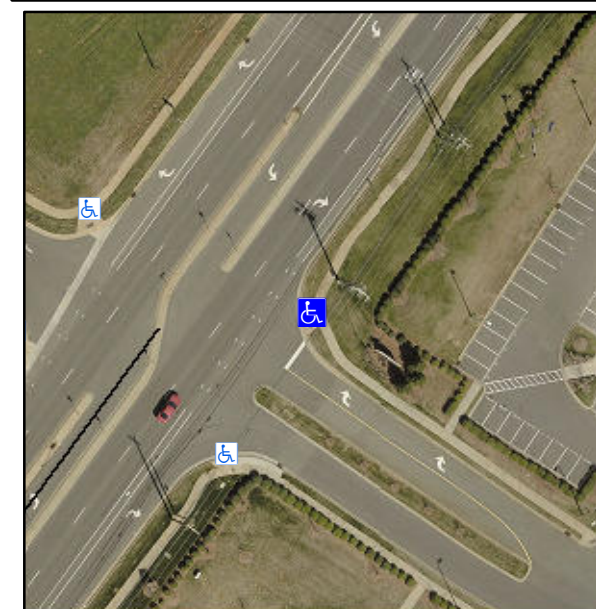
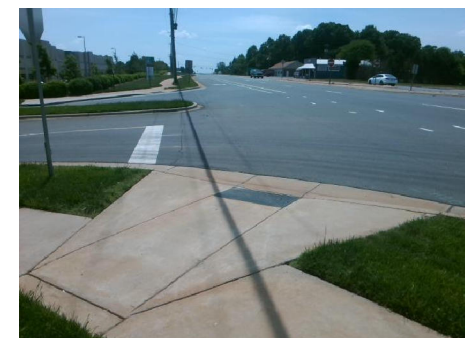
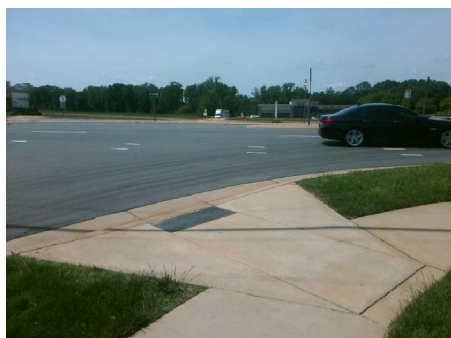
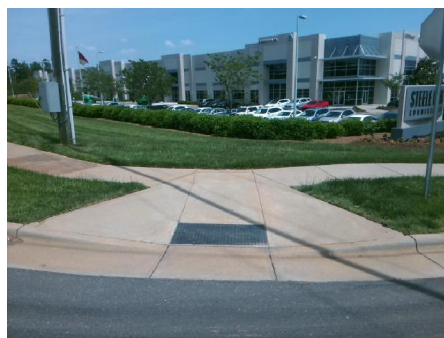
Compliance	Description	Data	Compliance	Description	Data
N/A	Ramp Length (in)	135.0	Yes	BlendTrans Slope (%)	3.9
No	Ramp Width (in)	47.0	No	BlendTrans XSlope (%)	6.1
N/A	Flare Type LT	N/A	N/A	Flare Type RT	N/A
N/A	Flare Slope LT (%)	N/A	N/A	Flare Slope RT (%)	N/A
N/A	Flare Traversable LT?	N/A	N/A	Flare Traversable RT?	N/A
N/A	Landing Length (in)	N/A	N/A	DWS Provided?	N/A
N/A	Landing Width (in)	N/A	N/A	DWS Contrast?	N/A
N/A	Landing Slope (%)	N/A	N/A	DWS Length (in)	N/A
N/A	Landing X Slope (%)	N/A	N/A	DWS Full Width?	N/A
N/A	Landing Curb? (Y/N)	N/A	N/A	DWS Offset (in)	N/A
N/A	Shared Landing?	N/A			
N/A	Gutter Ponding?	N/A	N/A	Gutter Slope (%)	N/A
N/A	Gutter Lip Ht (in)	N/A	N/A	Gutter X Slope (%)	N/A
N/A	Painted X Walk1?	No	N/A	Painted X Walk2?	No
	X Walk 1 Direction	To NW		X Walk 2 Direction	To SW
	X Walk 1 Width (in)	N/A		X Walk 2 Width (in)	N/A
	X Walk 1 Slope (%)	7.1		X Walk 2 Slope (%)	1.9
	X Walk 1 X Slope (%)	0.4		X Walk 2 X Slope (%)	4.7

N/A	Ramp inside XWalk1?	N/A	N/A	Ramp inside XWalk2?	N/A
	Road Slope (%)	4.8		Clear Space?	N/A
	Road X Slope (%)	6.6	N/A	Clear Space to XWalk (in)	N/A
N/A	Any Obstructions?	N/A	N/A	Storm Grate/Utility Hazard?	N/A
	Obstruction Type			Storm Grate/Utility Type	
		N/A			N/A
			Yes	Surface Condition? (G/P)	Good
			N/A	Curb Slope (%)	1.2

Possible Solutions:

Remove & Replace Curb Ramp With Two New Directional Ramps or Equivalent.

R304.5.1, R304.5.3
