Access Compliance Report

Public Rights-of-Way

(Curb Ramps)

Intersection ID: 11043	Main Street: BRIARHILL_DR	Cross Street: MILTON_RD	Location:	W
ADA ID: C6844EDE8A83	Ramp Type: PerpDiag	Initial Pass/Fail: Fail	Overall Compliance: No	Severity Score: 30
Codes/Mitigation Info/Possible Solution		Field Measurements/Component Compliance

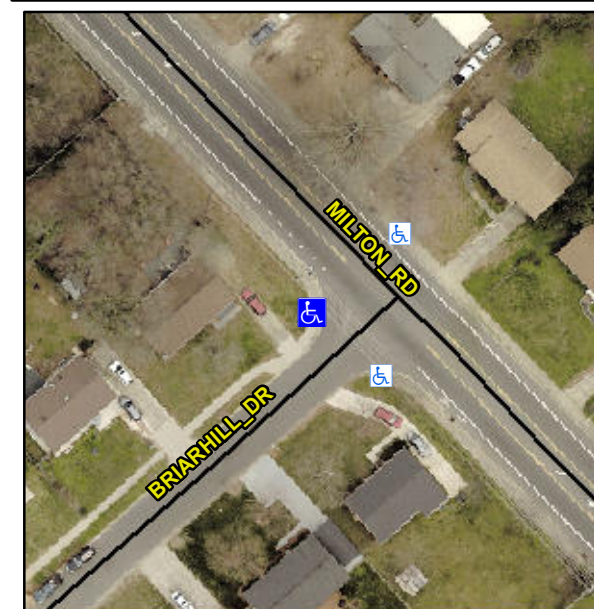
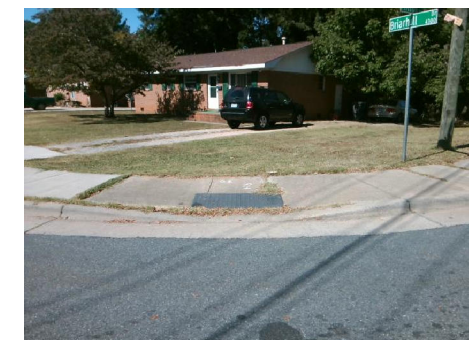
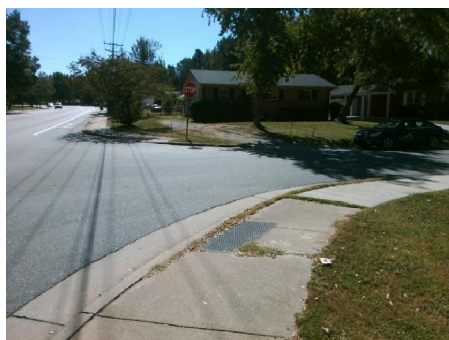
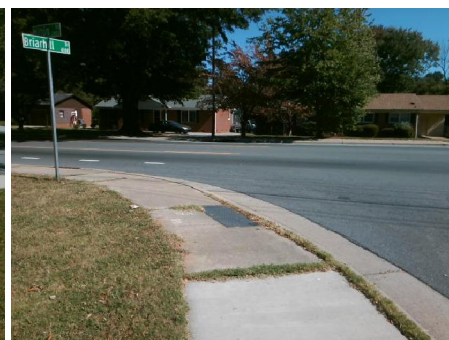
Not Found, R304.5.1, R304.2.2

Compliance	Description	Data	Compliance	Description	Data
N/A	Ramp Length (in)	59.0	No	Ramp Slope (%)	9.4
No	Ramp Width (in)	33.5	Yes	Ramp XSlope (%)	0.8
N/A	Flare Type LT	N/A	N/A	Flare Type RT	N/A
N/A	Flare Slope LT (%)	N/A	N/A	Flare Slope RT (%)	N/A
N/A	Flare Traversable LT?	N/A	N/A	Flare Traversable RT?	N/A
N/A	Landing Length (in)	N/A	N/A	DWS Provided?	N/A
N/A	Landing Width (in)	N/A	N/A	DWS Contrast?	N/A
N/A	Landing Slope (%)	N/A	N/A	DWS Length (in)	N/A
N/A	Landing X Slope (%)	N/A	N/A	DWS Full Width?	N/A
N/A	Landing Curb? (Y/N)	N/A	N/A	DWS Offset (in)	N/A
N/A	Shared Landing?	N/A			
N/A	Gutter Ponding?	N/A	N/A	Gutter Slope (%)	N/A
N/A	Gutter Lip Ht (in)	N/A	N/A	Gutter X Slope (%)	N/A
N/A	Painted X Walk1?	No	N/A	Painted X Walk2?	No
	X Walk 1 Direction	To SE		X Walk 2 Direction	To NE
N/A	X Walk 1 Width (in)	N/A	N/A	X Walk 2 Width (in)	N/A
	X Walk 1 Slope (%)	1.0		X Walk 2 Slope (%)	2.0
	X Walk 1 X Slope (%)	1.6		X Walk 2 X Slope (%)	0.9

N/A	Ramp inside XWalk1?	N/A	N/A	Ramp inside XWalk2?	N/A
	Road Slope (%)	1.6	N/A	Clear Space?	N/A
	Road X Slope (%)	0.0	N/A	Clear Space to XWalk (in)	N/A
N/A	Any Obstructions?	N/A	N/A	Storm Grate/Utility Hazard?	N/A
	Obstruction Type			Storm Grate/Utility Type	
		N/A			N/A
		Yes		Surface Condition? (G/P)	Good

Possible Solutions:

Remove & Replace Curb Ramp With Two New Directional Ramps or Equivalent.
