Access Compliance Report

Public Rights-of-Way

(Curb Ramps)

Intersection ID: 9326	Main Street: FAIRMONT_ST	Cross Street: OAKLAWN_AV	Location: NE
ADA ID: C684C5F227D1	Ramp Type: Perp	Initial Pass/Fail: Fail	Overall Compliance: No
Severity Score: 35			
Codes/Mitigation Info/Possible Solution		Field Measurements/Component Compliance

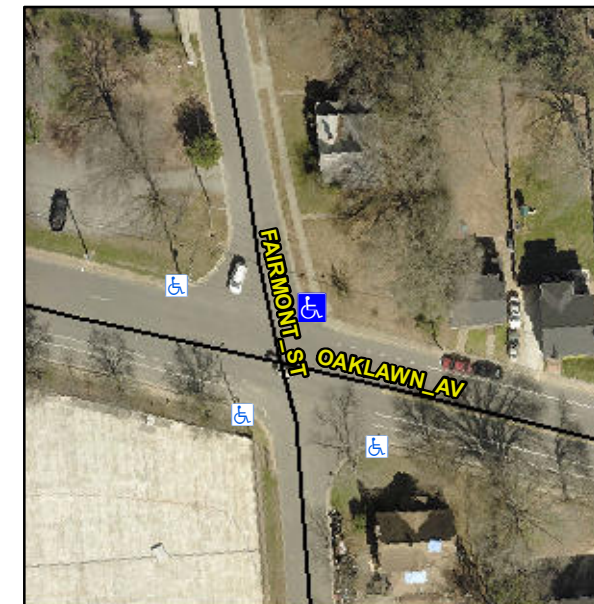
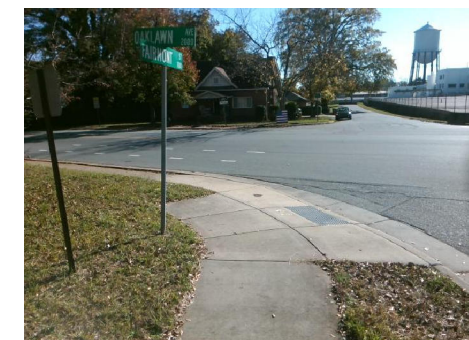
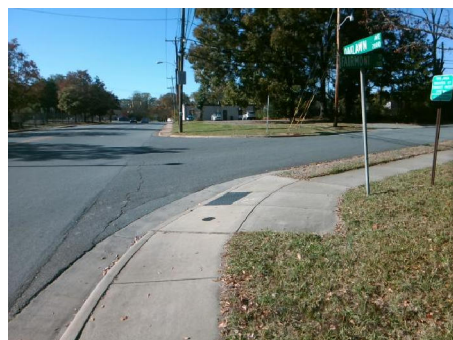
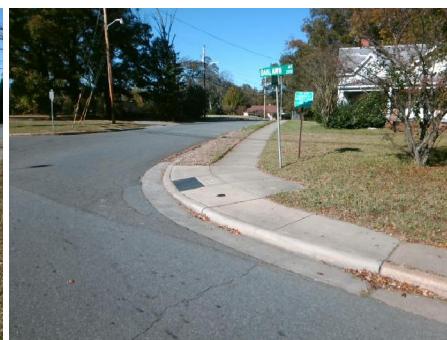
Not Found, R304.5.1, R304.2.2, R304.5.3

Compliance	Description	Data	Compliance	Description	Data
N/A	Ramp Length (in)	46.0	No	Ramp Slope (%)	12.3
No	Ramp Width (in)	46.5	No	Ramp XSlope (%)	2.5
N/A	Flare Type LT	N/A	N/A	Flare Type RT	N/A
N/A	Flare Slope LT (%)	N/A	N/A	Flare Slope RT (%)	N/A
N/A	Flare Traversable LT?	N/A	N/A	Flare Traversable RT?	N/A
N/A	Landing Length (in)	N/A	N/A	DWS Provided?	N/A
N/A	Landing Width (in)	N/A	N/A	DWS Contrast?	N/A
N/A	Landing Slope (%)	N/A	N/A	DWS Length (in)	N/A
N/A	Landing X Slope (%)	N/A	N/A	DWS Full Width?	N/A
N/A	Landing Curb? (Y/N)	N/A	N/A	DWS Offset (in)	N/A
N/A	Shared Landing?	N/A			
N/A	Gutter Ponding?	N/A	N/A	Gutter Slope (%)	N/A
N/A	Gutter Lip Ht (in)	N/A	N/A	Gutter X Slope (%)	N/A
N/A	Painted X Walk1?	No	N/A	Painted X Walk2?	N/A
	X Walk 1 Direction	To NW		X Walk 2 Direction	N/A
N/A	X Walk 1 Width (in)	N/A	N/A	X Walk 2 Width (in)	N/A
	X Walk 1 Slope (%)	2.3		X Walk 2 Slope (%)	N/A
	X Walk 1 X Slope (%)	1.1		X Walk 2 X Slope (%)	N/A

N/A	Ramp inside XWalk1?	N/A	N/A	Ramp inside XWalk2?	N/A
	Road Slope (%)	N/A	N/A	Clear Space?	N/A
	Road X Slope (%)	N/A	N/A	Clear Space to XWalk (in)	N/A
N/A	Any Obstructions?	N/A	N/A	Storm Grate/Utility Hazard?	N/A
	Obstruction Type			Storm Grate/Utility Type	
		N/A			N/A
			Yes	Surface Condition? (G/P)	Good

Remove & Replace Entire Ramp.
