Access Compliance Report

Public Rights-of-Way

(Curb Ramps)

Intersection ID: 7004	Main Street: CEDARHURST_DR	Cross Street: KENMONT_DR	Location: S
ADA ID: C697987AB574	Ramp Type: BlendTrans1	Initial Pass/Fail: Fail	Overall Compliance: No
Severity Score: 10			
Codes/Mitigation Info/Possible Solution		Field Measurements/Component Compliance

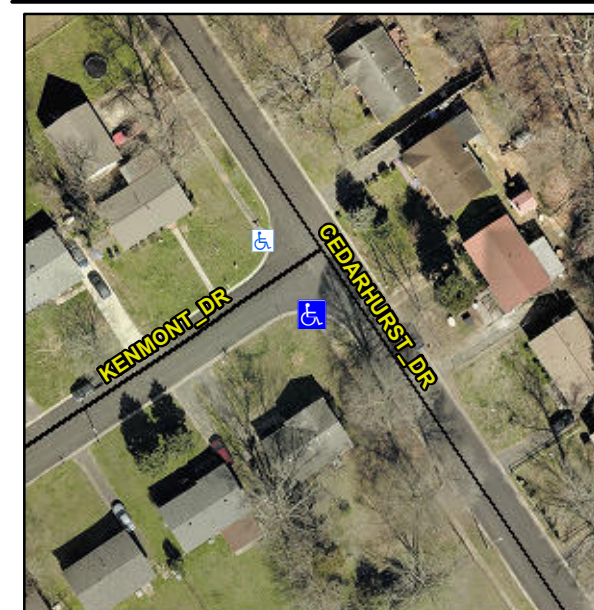
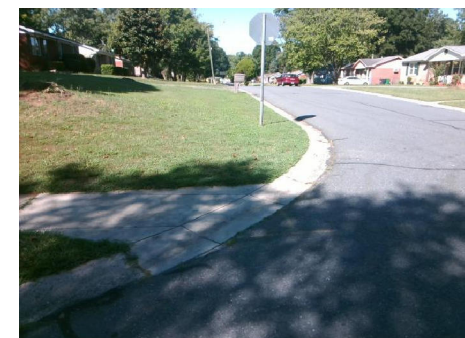
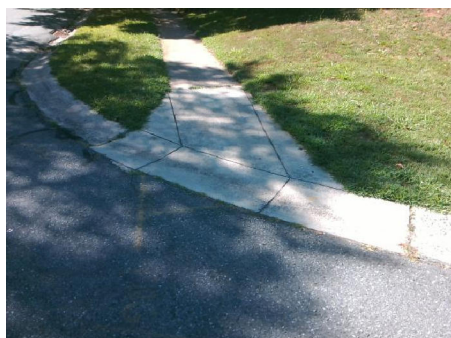
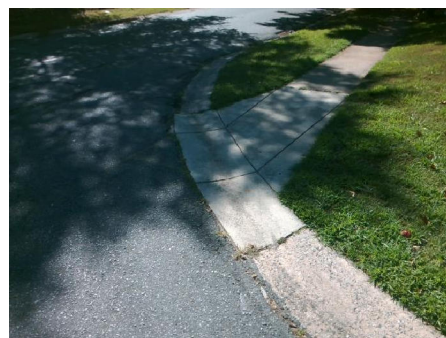
Not Found, R304.5.1, R304.5.3

Compliance	Description	Data	Compliance	Description	Data
N/A	Ramp Length (in)	76.0	Yes	BlendTrans Slope (%)	3.0
No	Ramp Width (in)	41.0	No	BlendTrans XSlope (%)	2.9
N/A	Flare Type LT	N/A	N/A	Flare Type RT	N/A
N/A	Flare Slope LT (%)	N/A	N/A	Flare Slope RT (%)	N/A
N/A	Flare Traversable LT?	N/A	N/A	Flare Traversable RT?	N/A
N/A	Landing Length (in)	N/A	N/A	DWS Provided?	N/A
N/A	Landing Width (in)	N/A	N/A	DWS Contrast?	N/A
N/A	Landing Slope (%)	N/A	N/A	DWS Length (in)	N/A
N/A	Landing X Slope (%)	N/A	N/A	DWS Full Width?	N/A
N/A	Landing Curb? (Y/N)	N/A	N/A	DWS Offset (in)	N/A
N/A	Shared Landing?	N/A			
N/A	Gutter Ponding?	N/A	N/A	Gutter Slope (%)	N/A
N/A	Gutter Lip Ht (in)	N/A	N/A	Gutter X Slope (%)	N/A
N/A	Painted X Walk1?	No	N/A	Painted X Walk2?	N/A
	X Walk 1 Direction	To NW		X Walk 2 Direction	N/A
	X Walk 1 Width (in)	N/A		X Walk 2 Width (in)	N/A
	X Walk 1 Slope (%)	3.9		X Walk 2 Slope (%)	N/A
	X Walk 1 X Slope (%)	0.0		X Walk 2 X Slope (%)	N/A

N/A	Ramp inside XWalk1?	N/A	N/A	Ramp inside XWalk2?	N/A
	Road Slope (%)	0.0		Clear Space?	N/A
	Road X Slope (%)	3.9	N/A	Clear Space to XWalk (in)	N/A
N/A	Any Obstructions?	N/A	N/A	Storm Grate/Utility Hazard?	N/A
	Obstruction Type			Storm Grate/Utility Type	
		N/A			N/A
			Yes	Surface Condition? (G/P)	Good
			No	Curb Slope (%)	15.3

Remove & Replace Curb Ramp With Two New Directional Ramps or Equivalent.
