Access Compliance Report

Public Rights-of-Way

(Curb Ramps)

Intersection ID: 10034609	Main Street: PLANTATION_CENTER_DR	Cross Street: N/A	Location: NW
ADA ID: C6A1DEE29E68	Ramp Type: Para	Initial Pass/Fail: Fail	Overall Compliance: No
Severity Score: 25			
Codes/Mitigation Info/Possible Solution		Field Measurements/Component Compliance

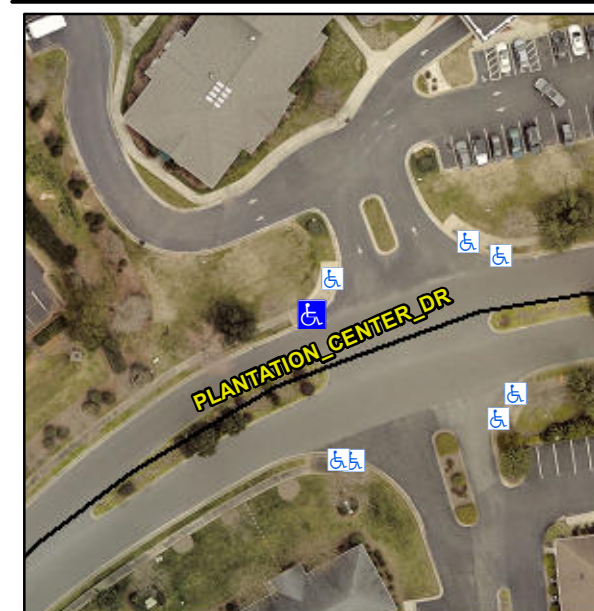
Compliance	Description	Data	Compliance	Description	Data
N/A	Ramp Length LT (in)	78.0	N/A	Ramp Length RT (in)	60.0
Yes	Ramp Width LT (in)	97.0	Yes	Ramp Width RT (in)	97.0
Yes	Ramp Slope LT (%)	5.6	No	Ramp Slope RT (%)	13.2
Yes	Ramp XSlope LT (%)	1.5	Yes	Ramp XSlope RT (%)	2.0
N/A	Landing Length (in)	N/A	N/A	DWS Provided?	N/A
N/A	Landing Width (in)	N/A	N/A	DWS Contrast?	N/A
N/A	Landing Slope (%)	N/A	N/A	DWS Length (in)	N/A
N/A	Landing X Slope (%)	N/A	N/A	DWS Full Width?	N/A
N/A	Landing Curb? (Y/N)	N/A	N/A	DWS Offset (in)	N/A
N/A	Shared Landing?	N/A			
N/A	Gutter Ponding?	N/A	N/A	Gutter Slope (%)	N/A
N/A	Gutter Lip Ht (in)	N/A	N/A	Gutter X Slope (%)	N/A
N/A	Painted X Walk1?	No	N/A	Painted X Walk2?	N/A
	X Walk 1 Direction	To SE		X Walk 2 Direction	N/A
N/A	X Walk 1 Width (in)	N/A	N/A	X Walk 2 Width (in)	N/A
	X Walk 1 Slope (%)	1.6		X Walk 2 Slope (%)	N/A
	X Walk 1 X Slope (%)	1.7		X Walk 2 X Slope (%)	N/A
N/A	Ramp inside XWalk1?	N/A	N/A	Ramp inside XWalk2?	N/A

Road Slope (%)	N/A	N/A	Clear Space?	N/A
	Road X Slope (%)	N/A	N/A	Clear Space to XWalk (in)	N/A
N/A	Any Obstructions?	N/A	N/A	Storm Grate/Utility Hazard?	N/A
	Obstruction Type			Storm Grate/Utility Type	
		N/A			N/A
			Yes	Surface Condition? (G/P)	Good
			N/A	Curb Slope (%)	12.0

Possible Solutions:

Remove & Replace Entire Ramp.
