# Access Compliance Report

## Public Rights-of-Way

### (Curb Ramps)

Intersection ID: 10019902	Main Street: ARCO_CORPORATE_DR	Cross Street: N/A	Location: NW
ADA ID: C6B663544EDE	Ramp Type: PerpDiag	Initial Pass/Fail: Fail	Overall Compliance: No
Severity Score: 46.25			
Codes/Mitigation Info/Possible Solution		Field Measurements/Component Compliance

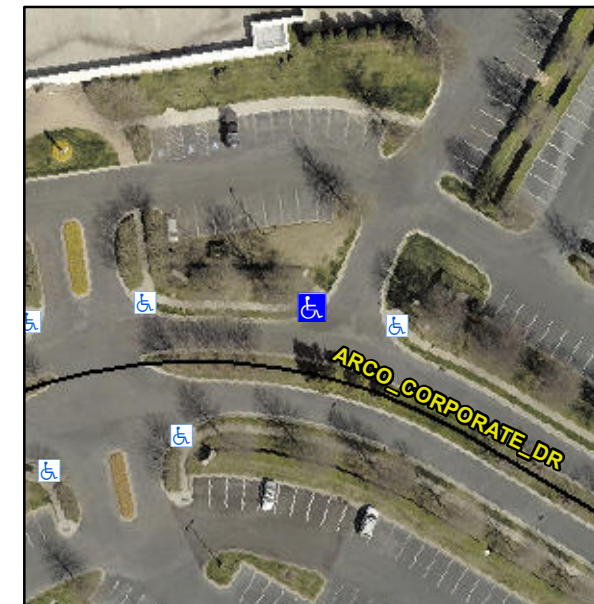
Compliance	Description	Data	Compliance	Description	Data
N/A	Ramp Length (in)	46.5	No	Ramp Slope (%)	12.3
No	Ramp Width (in)	37.8	No	Ramp XSlope (%)	5.1
N/A	Flare Type LT	N/A	N/A	Flare Type RT	N/A
N/A	Flare Slope LT (%)	N/A	N/A	Flare Slope RT (%)	N/A
N/A	Flare Traversable LT?	N/A	N/A	Flare Traversable RT?	N/A
N/A	Landing Length (in)	N/A	N/A	DWS Provided?	N/A
N/A	Landing Width (in)	N/A	N/A	DWS Contrast?	N/A
N/A	Landing Slope (%)	N/A	N/A	DWS Length (in)	N/A
N/A	Landing X Slope (%)	N/A	N/A	DWS Full Width?	N/A
N/A	Landing Curb? (Y/N)	N/A	N/A	DWS Offset (in)	N/A
N/A	Shared Landing?	N/A			
N/A	Gutter Ponding?	N/A	N/A	Gutter Slope (%)	N/A
N/A	Gutter Lip Ht (in)	1.0	N/A	Gutter X Slope (%)	N/A
N/A	Painted X Walk1?	No	N/A	Painted X Walk2?	No
	X Walk 1 Direction	To SW		X Walk 2 Direction	To SE
N/A	X Walk 1 Width (in)	N/A	N/A	X Walk 2 Width (in)	N/A
	X Walk 1 Slope (%)	1.1		X Walk 2 Slope (%)	1.5
	X Walk 1 X Slope (%)	2.0		X Walk 2 X Slope (%)	3.0

N/A	Ramp inside XWalk1?	N/A	N/A	Ramp inside XWalk2?	N/A
	Road Slope (%)	2.7	N/A	Clear Space?	N/A
	Road X Slope (%)	3.4	N/A	Clear Space to XWalk (in)	N/A
N/A	Any Obstructions?	N/A	N/A	Storm Grate/Utility Hazard?	N/A
	Obstruction Type			Storm Grate/Utility Type	
		N/A			N/A
			Yes	Surface Condition? (G/P)	Good

Possible Solutions:

**Remove & Replace Curb Ramp With Two New Directional Ramps or Equivalent.**
