# Access Compliance Report

## Public Rights-of-Way

| Intersection ID: 29374 | Main Street: BUCKVALLEY_DR | Cross Street: PLEASANT_DALE_DR | Location: SE |
| ADA ID: C6B724FAB529 | Ramp Type: PerpDiag | Initial Pass/Fail: Fail | Overall Compliance: No |

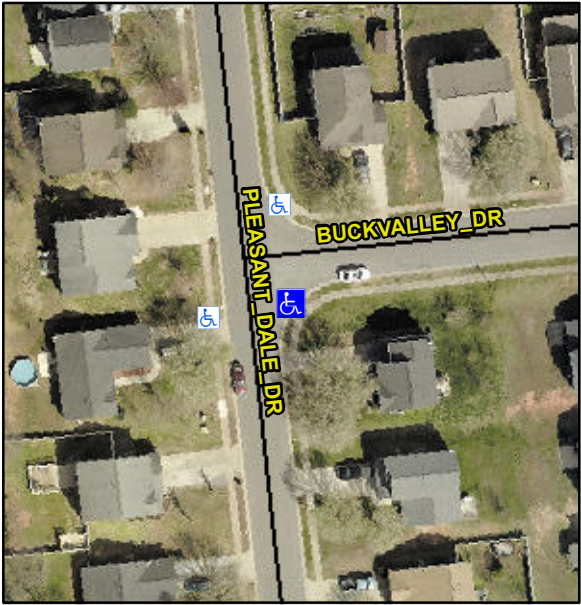
| Severity Score: 12.5 | | | |

| | | Yes | Ramp Width (in) | 48.0 | No | Ramp XSlope (%) | 5.1 |
| <p>Surveyor Notes:</p> <p>N/A</p> <p>PROW/ADA:</p> <p>Not Found, R304.5.3</p> | | | Road Slope (%) | 2.7 | N/A | Clear Space? | N/A |

| | Remove & Replace Curb Ramp With Two New Directional Ramps or Equivalent. | N/A | Ramp Length (in) | 47.0 | Yes | Ramp Slope (%) | 5.2 |
