Access Compliance Report

Public Rights-of-Way

(Curb Ramps)

Intersection ID: 14739	Main Street: DARTMOUTH_PL	Cross Street: PROVIDENCE_RD	Location: SW
ADA ID: C6B76CDC21DE	Ramp Type: PerpDiag	Initial Pass/Fail: Fail	Overall Compliance: No
Severity Score: 21.25			
Codes/Mitigation Info/Possible Solution		Field Measurements/Component Compliance

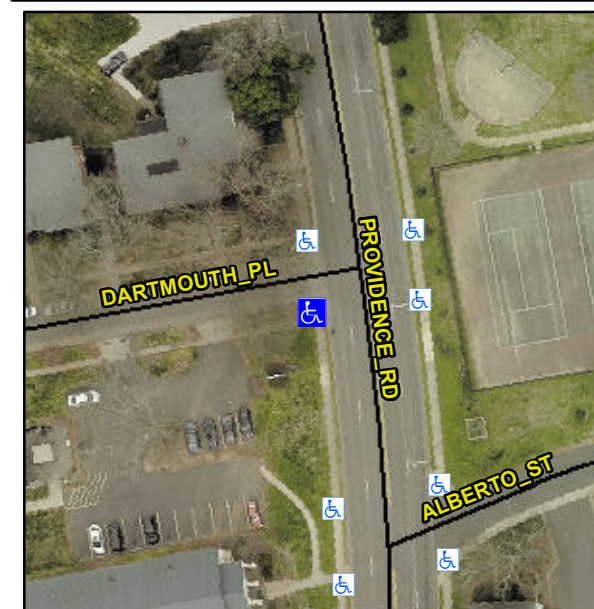
Not Found, R304.5.1, R304.5.3

Compliance	Description	Data	Compliance	Description	Data
N/A	Ramp Length (in)	92.0	Yes	Ramp Slope (%)	7.4
No	Ramp Width (in)	40.0	No	Ramp XSlope (%)	5.8
N/A	Flare Type LT	N/A	N/A	Flare Type RT	N/A
N/A	Flare Slope LT (%)	N/A	N/A	Flare Slope RT (%)	N/A
N/A	Flare Traversable LT?	N/A	N/A	Flare Traversable RT?	N/A
N/A	Landing Length (in)	N/A	N/A	DWS Provided?	N/A
N/A	Landing Width (in)	N/A	N/A	DWS Contrast?	N/A
N/A	Landing Slope (%)	N/A	N/A	DWS Length (in)	N/A
N/A	Landing X Slope (%)	N/A	N/A	DWS Full Width?	N/A
N/A	Landing Curb? (Y/N)	N/A	N/A	DWS Offset (in)	N/A
N/A	Shared Landing?	N/A			
N/A	Gutter Ponding?	N/A	N/A	Gutter Slope (%)	N/A
N/A	Gutter Lip Ht (in)	N/A	N/A	Gutter X Slope (%)	N/A
N/A	Painted X Walk1?	No	N/A	Painted X Walk2?	No
	X Walk 1 Direction	To E		X Walk 2 Direction	To N
N/A	X Walk 1 Width (in)	N/A	N/A	X Walk 2 Width (in)	N/A
	X Walk 1 Slope (%)	2.7		X Walk 2 Slope (%)	1.0
	X Walk 1 X Slope (%)	2.4		X Walk 2 X Slope (%)	5.3

N/A	Ramp inside XWalk1?	N/A	N/A	Ramp inside XWalk2?	N/A
	Road Slope (%)	5.6	N/A	Clear Space?	N/A
	Road X Slope (%)	4.6	N/A	Clear Space to XWalk (in)	N/A
N/A	Any Obstructions?	N/A	N/A	Storm Grate/Utility Hazard?	N/A
	Obstruction Type			Storm Grate/Utility Type	
		N/A			N/A
		Yes		Surface Condition? (G/P)	Good

Possible Solutions:

Remove & Replace Curb Ramp With Two New Directional Ramps or Equivalent.
