# Access Compliance Report

## Public Rights-of-Way

### (Curb Ramps)

Intersection ID: 28240	Main Street: FORTBRIDGE_LN	Cross Street: SUMMER CLUB_RD	Location: NE
ADA ID: C6BBDDC0BB4B	Ramp Type: PerpDiag	Initial Pass/Fail: Fail	Overall Compliance: No
Severity Score: 13.75			
Codes/Mitigation Info/Possible Solution		Field Measurements/Component Compliance

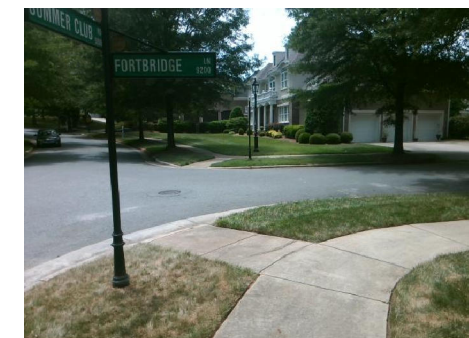
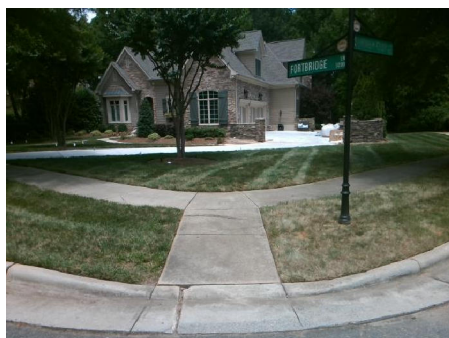
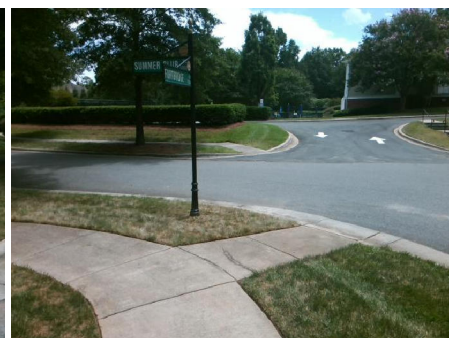
Street 1 Name **FORTBRIDGE LN**  
 Stop Condition-Street 2 **StopSign**  
 Street 2 Name **SUMMER CLUB RD**  
 Stop Condition-Street 1 **None**
