Access Compliance Report

Public Rights-of-Way

(Curb Ramps)

Intersection ID: 21109	Main Street: OAKHAVEN_DR	Cross Street: SANDY_PORTER_RD	Location: SW
ADA ID: C6BCE16A4671	Ramp Type: Directional1	Initial Pass/Fail: Fail	Overall Compliance: No
Severity Score: 1.25			
Codes/Mitigation Info/Possible Solution		Field Measurements/Component Compliance

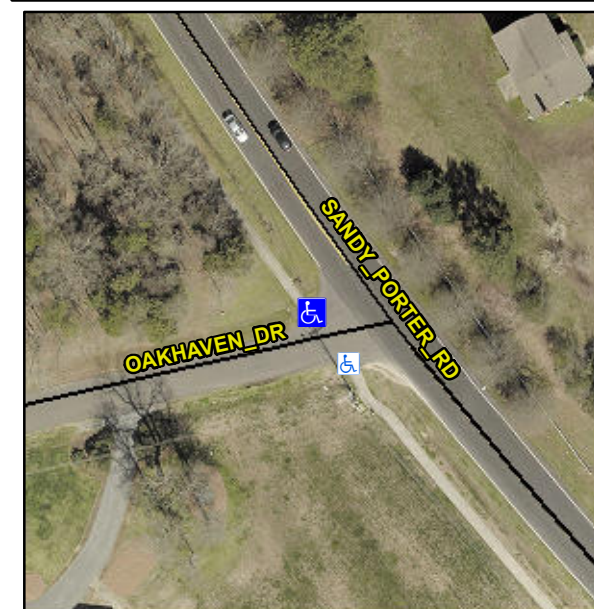
PROW/ADA:

R304.5.3

Compliance	Description	Data	Compliance	Description	Data
N/A	Ramp Length (in)	53.0	N/A	Grade Break?	N/A
Yes	Ramp Width (in)	66.0	N/A	Grade Break Slope (%)	0.0
Yes	Ramp Slope (%)	3.9	N/A	Grade Break XSlope (%)	0.0
No	Ramp XSlope (%)	3.2			
N/A	Flare Type LT	N/A	N/A	Flare Type RT	N/A
N/A	Flare Slope LT (%)	N/A	N/A	Flare Slope RT (%)	0.0
N/A	Flare Traversable LT?	N/A	N/A	Flare Traversable RT?	N/A
N/A	Landing Length (in)	0.0	N/A	DWS Provided?	N/A
N/A	Landing Width (in)	0.0	N/A	DWS Contrast?	N/A
N/A	Landing Slope (%)	0.0	N/A	DWS Length (in)	N/A
N/A	Landing X Slope (%)	0.0	N/A	DWS Full Width?	N/A
N/A	Landing Curb? (Y/N)	N/A	N/A	DWS Offset LT (in)	N/A
N/A	Shared Landing?	N/A	N/A	DWS Offset RT (in)	N/A
N/A	Gutter Ponding?	0.0	N/A	Gutter Slope (%)	N/A
N/A	Gutter Lip Ht (in)	0.0	N/A	Gutter X Slope (%)	N/A
N/A	Painted X Walk1?	No		Road Slope (%)	1.4
	X Walk 1 Direction	To SE		Road X Slope (%)	0.8
	X Walk 1 Width (in)	N/A		Clear Space?	N/A

X Walk 1 Slope (%)	1.4	N/A	Clear Space to XWalk (in)	N/A
	X Walk 1 X Slope (%)	0.8	N/A	Storm Grate/Utility Hazard?	N/A
N/A	Ramp inside XWalk1?	N/A		Storm Grate/Utility Type	
N/A	Any Obstructions?	N/A			N/A
	Obstruction Type		Yes	Surface Condition? (G/P)	Good
			N/A	Curb Slope (%)	8.4

Possible Solutions:

Remove & Replace Entire Ramp.
