Access Compliance Report

Public Rights-of-Way

(Curb Ramps)

Intersection ID: 18365	Main Street: S_TRYON_ST	Cross Street: W_TYVOLA_RD	Location: SW
ADA ID: C6D4F9069429	Ramp Type: PerpDiag	Initial Pass/Fail: Pass	Overall Compliance: No
Severity Score: 20			
Codes/Mitigation Info/Possible Solution		Field Measurements/Component Compliance

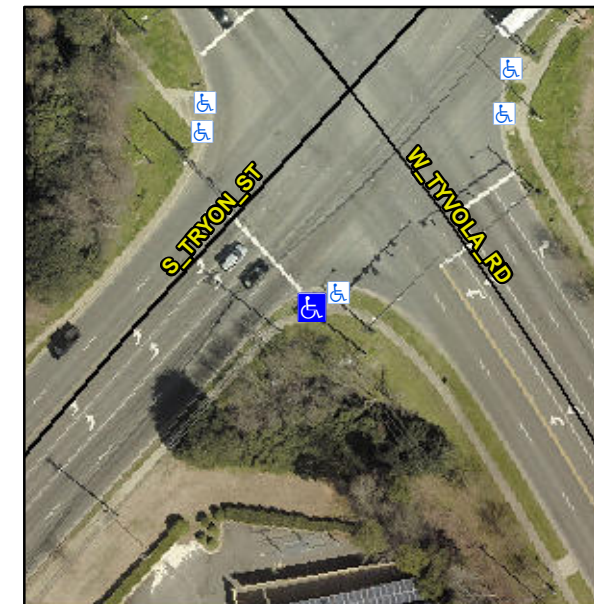
Compliance	Description	Data	Compliance	Description	Data
N/A	Ramp Length (in)	104.0	Yes	Ramp Slope (%)	5.6
Yes	Ramp Width (in)	48.0	Yes	Ramp XSlope (%)	0.6
N/A	Flare Type LT	Sloped	N/A	Flare Type RT	N/A
N/A	Flare Slope LT (%)	12.2	N/A	Flare Slope RT (%)	8.5
N/A	Flare Traversable LT?	Yes	N/A	Flare Traversable RT?	No
Yes	Landing Length (in)	48.0	Yes	DWS Provided?	Yes
Yes	Landing Width (in)	60.0	Yes	DWS Contrast?	Yes
No	Landing Slope (%)	2.5	Yes	DWS Length (in)	24.0
Yes	Landing X Slope (%)	1.4	Yes	DWS Full Width?	Yes
N/A	Landing Curb? (Y/N)	No	No	DWS Offset (in)	3.5
N/A	Shared Landing?	No			
Yes	Gutter Ponding?	No	Yes	Gutter Slope (%)	4.8
No	Gutter Lip Ht (in)	1.0	Yes	Gutter X Slope (%)	1.5
N/A	Painted X Walk1?	No	N/A	Painted X Walk2?	No
	X Walk 1 Direction	To NE		X Walk 2 Direction	To NW
N/A	X Walk 1 Width (in)	N/A	N/A	X Walk 2 Width (in)	N/A
	X Walk 1 Slope (%)	0.6		X Walk 2 Slope (%)	2.3
	X Walk 1 X Slope (%)	1.8		X Walk 2 X Slope (%)	0.8

N/A	Ramp inside XWalk1?	N/A	N/A	Ramp inside XWalk2?	N/A
	Road Slope (%)	2.1	N/A	Clear Space?	Yes
	Road X Slope (%)	3.6	N/A	Clear Space to XWalk (in)	N/A
Yes	Any Obstructions?	No	Yes	Storm Grate/Utility Hazard?	No
	Obstruction Type			Storm Grate/Utility Type	
		N/A			N/A
			Yes	Surface Condition? (G/P)	Good

Possible Solutions:

Remove & Replace Curb Ramp With Two New Directional Ramps or Equivalent. Grind Gutter Lip.

R304.2.2-Perp, R304.3.2-Para, R304.2.3, R305.2, R302.7.2
