# Access Compliance Report

## Public Rights-of-Way

### (Curb Ramps)

Intersection ID: 14459	Main Street: CROSS_CREEK_LN	Cross Street: FARM_POND_LN	Location:	N
ADA ID: C6D828C24962	Ramp Type: BlendTrans1	Initial Pass/Fail: Fail	Overall Compliance: No	Severity Score: 10

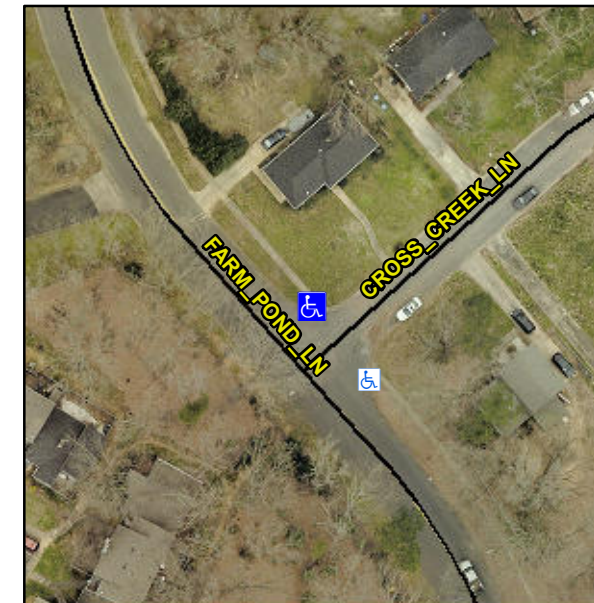
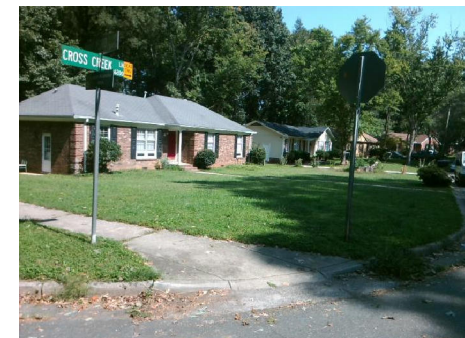
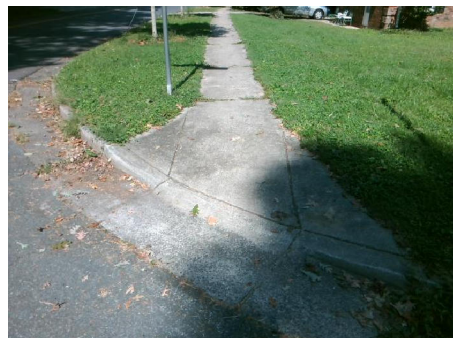
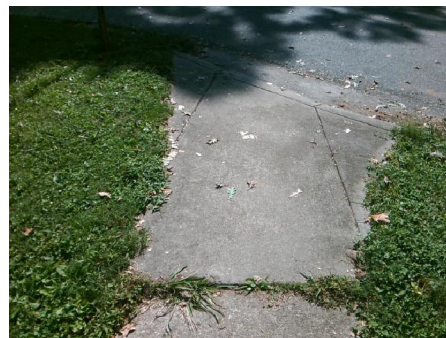
**Not Found, R304.5.1, R304.5.3**

Compliance	Description	Data	Compliance	Description	Data
N/A	Ramp Length (in)	80.0	Yes	BlendTrans Slope (%)	3.3
No	Ramp Width (in)	41.0	No	BlendTrans XSlope (%)	2.5
N/A	Flare Type LT	N/A	N/A	Flare Type RT	N/A
N/A	Flare Slope LT (%)	N/A	N/A	Flare Slope RT (%)	N/A
N/A	Flare Traversable LT?	N/A	N/A	Flare Traversable RT?	N/A
N/A	Landing Length (in)	N/A	N/A	DWS Provided?	N/A
N/A	Landing Width (in)	N/A	N/A	DWS Contrast?	N/A
N/A	Landing Slope (%)	N/A	N/A	DWS Length (in)	N/A
N/A	Landing X Slope (%)	N/A	N/A	DWS Full Width?	N/A
N/A	Landing Curb? (Y/N)	N/A	N/A	DWS Offset (in)	N/A
N/A	Shared Landing?	N/A			
N/A	Gutter Ponding?	N/A	N/A	Gutter Slope (%)	N/A
N/A	Gutter Lip Ht (in)	N/A	N/A	Gutter X Slope (%)	N/A
N/A	Painted X Walk1?	No	N/A	Painted X Walk2?	N/A
	X Walk 1 Direction	To SE		X Walk 2 Direction	N/A
	X Walk 1 Width (in)	N/A		X Walk 2 Width (in)	N/A
	X Walk 1 Slope (%)	5.5		X Walk 2 Slope (%)	N/A
	X Walk 1 X Slope (%)	1.4		X Walk 2 X Slope (%)	N/A

N/A	Ramp inside XWalk1?	N/A	N/A	Ramp inside XWalk2?	N/A
	Road Slope (%)	1.4		Clear Space?	N/A
	Road X Slope (%)	5.5	N/A	Clear Space to XWalk (in)	N/A
N/A	Any Obstructions?	N/A	N/A	Storm Grate/Utility Hazard?	N/A
	Obstruction Type			Storm Grate/Utility Type	
		N/A			N/A
			Yes	Surface Condition? (G/P)	Good
			No	Curb Slope (%)	15.6

**Remove & Replace Curb Ramp With Two New Directional Ramps or Equivalent.**
