Access Compliance Report

Public Rights-of-Way

(Curb Ramps)

Intersection ID: 11907	Main Street: PHIFER_AV	Cross Street: N_COLLEGE_ST	Location: W
ADA ID: C6E58219ADFD	Ramp Type: Directional1	Initial Pass/Fail: Fail	Overall Compliance: No
		Severity Score: 10

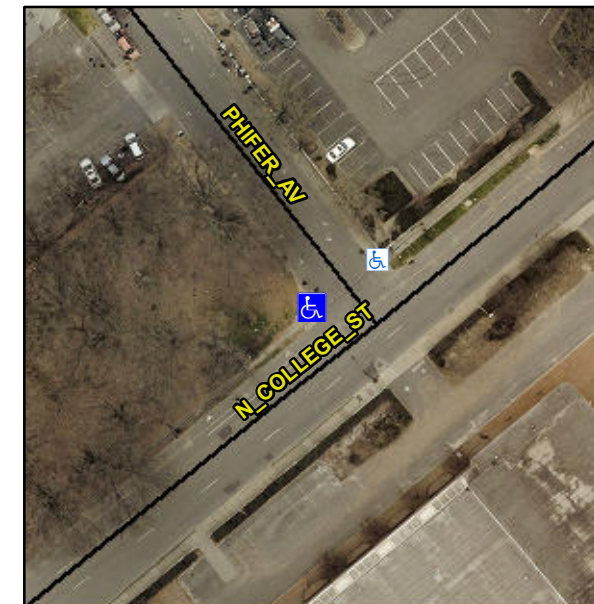
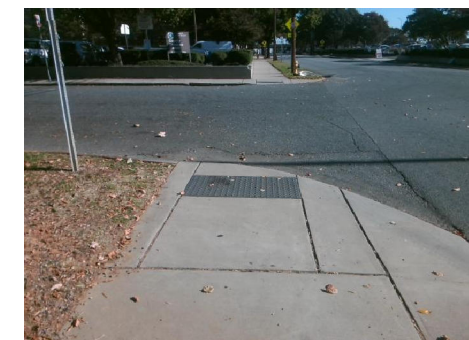
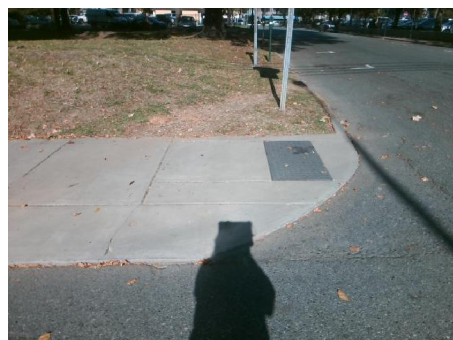
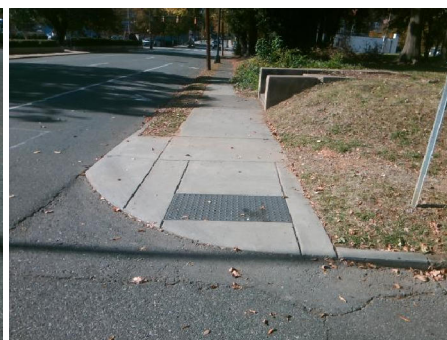
Compliance	Description	Data	Compliance	Description	Data
N/A	Ramp Length (in)	76.0	N/A	Grade Break?	N/A
No	Ramp Width (in)	47.5	N/A	Grade Break Slope (%)	0.0
Yes	Ramp Slope (%)	2.8	N/A	Grade Break XSlope (%)	0.0
No	Ramp XSlope (%)	3.6			
N/A	Flare Type LT	N/A	N/A	Flare Type RT	N/A
N/A	Flare Slope LT (%)	N/A	N/A	Flare Slope RT (%)	0.0
N/A	Flare Traversable LT?	N/A	N/A	Flare Traversable RT?	N/A
N/A	Landing Length (in)	0.0	N/A	DWS Provided?	N/A
N/A	Landing Width (in)	0.0	N/A	DWS Contrast?	N/A
N/A	Landing Slope (%)	0.0	N/A	DWS Length (in)	N/A
N/A	Landing X Slope (%)	0.0	N/A	DWS Full Width?	N/A
N/A	Landing Curb? (Y/N)	N/A	N/A	DWS Offset LT (in)	N/A
N/A	Shared Landing?	N/A	N/A	DWS Offset RT (in)	N/A
N/A	Gutter Ponding?	0.0	N/A	Gutter Slope (%)	N/A
N/A	Gutter Lip Ht (in)	0.5	N/A	Gutter X Slope (%)	N/A
N/A	Painted X Walk1?	No		Road Slope (%)	6.5
	X Walk 1 Direction	To NE		Road X Slope (%)	0.6
	X Walk 1 Width (in)	N/A		Clear Space?	N/A

X Walk 1 Slope (%)	6.5	N/A	Clear Space to XWalk (in)	N/A
	X Walk 1 X Slope (%)	0.6	N/A	Storm Grate/Utility Hazard?	N/A
N/A	Ramp inside XWalk1?	N/A		Storm Grate/Utility Type	
N/A	Any Obstructions?	N/A			N/A
	Obstruction Type		Yes	Surface Condition? (G/P)	Good
			N/A	Curb Slope (%)	3.3

Possible Solutions:

Remove & Replace Entire Ramp.

R304.5.1, R304.5.3

Total Cost: \$ 1600.00
