Access Compliance Report

Public Rights-of-Way

(Curb Ramps)

Intersection ID: 45303	Main Street: CINDY_CREEK_LN	Cross Street: CINDY_WOODS_LN	Location: NW
ADA ID: C6E93646FB52	Ramp Type: PerpDiag	Initial Pass/Fail: Fail	Overall Compliance: No
Severity Score: 42.5			
Codes/Mitigation Info/Possible Solution		Field Measurements/Component Compliance

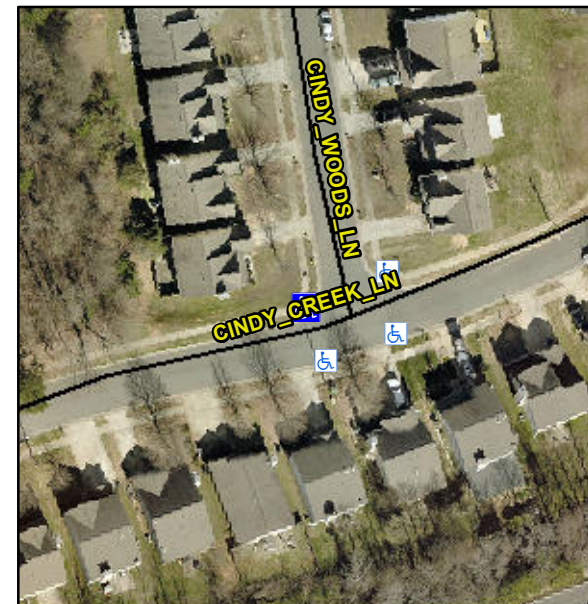
Not Found, R304.5.1, R304.5.3

Compliance	Description	Data	Compliance	Description	Data
N/A	Ramp Length (in)	52.0	Yes	Ramp Slope (%)	5.8
No	Ramp Width (in)	34.0	No	Ramp XSlope (%)	7.0
N/A	Flare Type LT	N/A	N/A	Flare Type RT	N/A
N/A	Flare Slope LT (%)	N/A	N/A	Flare Slope RT (%)	N/A
N/A	Flare Traversable LT?	N/A	N/A	Flare Traversable RT?	N/A
N/A	Landing Length (in)	N/A	N/A	DWS Provided?	N/A
N/A	Landing Width (in)	N/A	N/A	DWS Contrast?	N/A
N/A	Landing Slope (%)	N/A	N/A	DWS Length (in)	N/A
N/A	Landing X Slope (%)	N/A	N/A	DWS Full Width?	N/A
N/A	Landing Curb? (Y/N)	N/A	N/A	DWS Offset (in)	N/A
N/A	Shared Landing?	N/A			
N/A	Gutter Ponding?	N/A	N/A	Gutter Slope (%)	N/A
N/A	Gutter Lip Ht (in)	N/A	N/A	Gutter X Slope (%)	N/A
N/A	Painted X Walk1?	No	N/A	Painted X Walk2?	No
	X Walk 1 Direction	To S		X Walk 2 Direction	To E
N/A	X Walk 1 Width (in)	N/A	N/A	X Walk 2 Width (in)	N/A
	X Walk 1 Slope (%)	0.7		X Walk 2 Slope (%)	5.2
	X Walk 1 X Slope (%)	5.4		X Walk 2 X Slope (%)	0.5

N/A	Ramp inside XWalk1?	N/A	N/A	Ramp inside XWalk2?	N/A
	Road Slope (%)	2.9	N/A	Clear Space?	N/A
	Road X Slope (%)	0.0	N/A	Clear Space to XWalk (in)	N/A
N/A	Any Obstructions?	N/A	N/A	Storm Grate/Utility Hazard?	N/A
	Obstruction Type			Storm Grate/Utility Type	
		N/A			N/A
		Yes		Surface Condition? (G/P)	Good

Remove & Replace Curb Ramp With Two New Directional Ramps or Equivalent.
