Access Compliance Report

Public Rights-of-Way

(Curb Ramps)

Intersection ID: 10154	Main Street: SLOAN_DR	Cross Street: TUCKASEEGEE_RD	Location: S
ADA ID: C6ECA0C755BF	Ramp Type: Perp	Initial Pass/Fail: Fail	Overall Compliance: No
Severity Score: 12.5			
Codes/Mitigation Info/Possible Solution		Field Measurements/Component Compliance

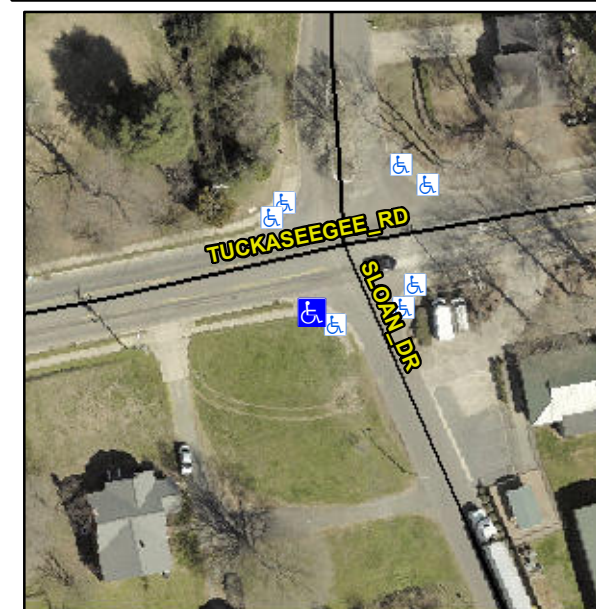
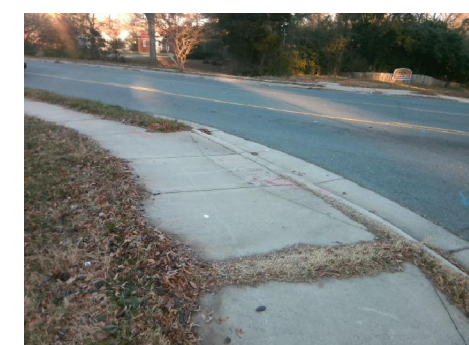
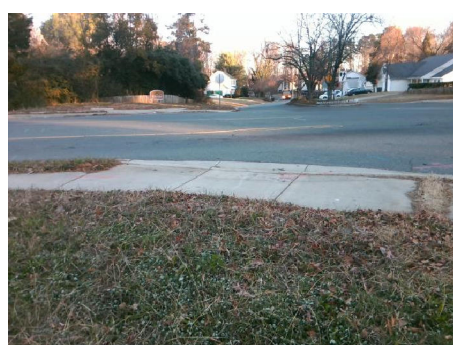
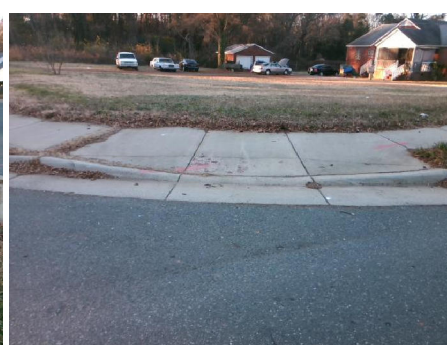
Not Found, R304.2.2

Compliance	Description	Data	Compliance	Description	Data
N/A	Ramp Length (in)	84.0	No	Ramp Slope (%)	8.8
Yes	Ramp Width (in)	53.0	Yes	Ramp XSlope (%)	1.3
N/A	Flare Type LT	N/A	N/A	Flare Type RT	N/A
N/A	Flare Slope LT (%)	N/A	N/A	Flare Slope RT (%)	N/A
N/A	Flare Traversable LT?	N/A	N/A	Flare Traversable RT?	N/A
N/A	Landing Length (in)	N/A	N/A	DWS Provided?	N/A
N/A	Landing Width (in)	N/A	N/A	DWS Contrast?	N/A
N/A	Landing Slope (%)	N/A	N/A	DWS Length (in)	N/A
N/A	Landing X Slope (%)	N/A	N/A	DWS Full Width?	N/A
N/A	Landing Curb? (Y/N)	N/A	N/A	DWS Offset (in)	N/A
N/A	Shared Landing?	N/A			
N/A	Gutter Ponding?	N/A	N/A	Gutter Slope (%)	N/A
N/A	Gutter Lip Ht (in)	N/A	N/A	Gutter X Slope (%)	N/A
N/A	Painted X Walk1?	No	N/A	Painted X Walk2?	N/A
	X Walk 1 Direction	To N		X Walk 2 Direction	N/A
N/A	X Walk 1 Width (in)	N/A	N/A	X Walk 2 Width (in)	N/A
	X Walk 1 Slope (%)	1.3		X Walk 2 Slope (%)	N/A
	X Walk 1 X Slope (%)	0.1		X Walk 2 X Slope (%)	N/A

N/A	Ramp inside XWalk1?	N/A	N/A	Ramp inside XWalk2?	N/A
	Road Slope (%)	N/A	N/A	Clear Space?	N/A
	Road X Slope (%)	N/A	N/A	Clear Space to XWalk (in)	N/A
N/A	Any Obstructions?	N/A	N/A	Storm Grate/Utility Hazard?	N/A
	Obstruction Type			Storm Grate/Utility Type	
		N/A			N/A
			Yes	Surface Condition? (G/P)	Good

Remove & Replace Entire Ramp.

Total Cost: \$ 1850.00
