# Access Compliance Report

## Public Rights-of-Way

### (Curb Ramps)

Intersection ID: 10215	Main Street: JOYCE_DR	Cross Street: MILTON_RD	Location: NW
ADA ID: C6ED53685371	Ramp Type: PerpDiag	Initial Pass/Fail: Fail	Overall Compliance: No
Codes/Mitigation Info/Possible Solution		Field Measurements/Component Compliance

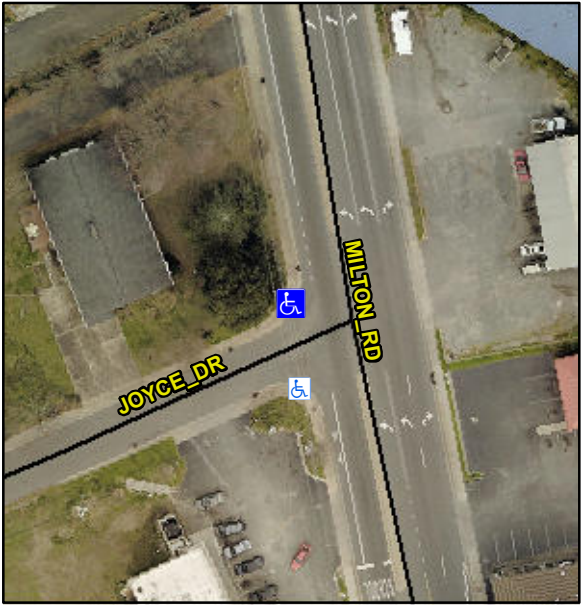
Possible Solutions:	Compliance	Description	Data	Compliance	Description	Data
	Remove & Replace Curb Ramp With Two New Directional Ramps or Equivalent.	N/A	Ramp Length (in)	60.0	No	Ramp Slope (%)	10.8
		No	Ramp Width (in)	44.0	Yes	Ramp XSlope (%)	0.5
		N/A	Flare Type LT	N/A	N/A	Flare Type RT	N/A
		N/A	Flare Slope LT (%)	N/A	N/A	Flare Slope RT (%)	N/A
		N/A	Flare Traversable LT?	N/A	N/A	Flare Traversable RT?	N/A
		N/A	Landing Length (in)	N/A	N/A	DWS Provided?	N/A
		N/A	Landing Width (in)	N/A	N/A	DWS Contrast?	N/A
		N/A	Landing Slope (%)	N/A	N/A	DWS Length (in)	N/A
		N/A	Landing X Slope (%)	N/A	N/A	DWS Full Width?	N/A
		N/A	Landing Curb? (Y/N)	N/A	N/A	DWS Offset (in)	N/A
		N/A	Shared Landing?	N/A			
		N/A	Gutter Ponding?	N/A	N/A	Gutter Slope (%)	N/A
		N/A	Gutter Lip Ht (in)	N/A	N/A	Gutter X Slope (%)	N/A
		N/A	Painted X Walk1?	No	N/A	Painted X Walk2?	No
			X Walk 1 Direction	To S		X Walk 2 Direction	To E

N/A	X Walk 1 Width (in)	N/A	N/A	X Walk 2 Width (in)	N/A
			X Walk 1 Slope (%)	1.7		X Walk 2 Slope (%)	0.3
			X Walk 1 X Slope (%)	1.7		X Walk 2 X Slope (%)	2.1
		N/A	Ramp inside XWalk1?	N/A	N/A	Ramp inside XWalk2?	N/A
<p>Surveyor Notes:</p> <p>N/A</p> <p>PROW/ADA:</p> <p>Not Found, R304.5.1, R304.2.2</p>			Road Slope (%)	0.3	N/A	Clear Space?	N/A
			Road X Slope (%)	2.2	N/A	Clear Space to XWalk (in)	N/A
		N/A	Any Obstructions?	N/A	N/A	Storm Grate/Utility Hazard?	N/A
			Obstruction Type			Storm Grate/Utility Type	
					N/A		N/A
					Yes	Surface Condition? (G/P)	Good
