Intersection ID: 10037015	Main Street: S_TRYON_ST	Cross Street: N/A	Location:	E
ADA ID: C6F2CC4F6AE8	Ramp Type: BlendTrans1	Initial Pass/Fail: Fail	Overall Compliance: No	Severity Score: 33.75

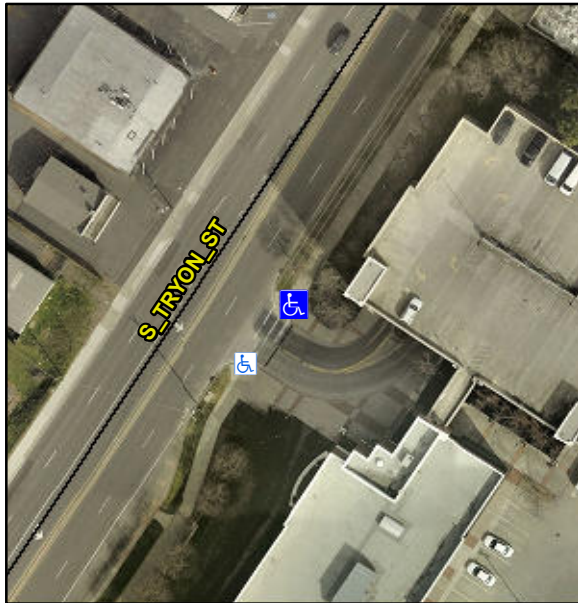
Not Found, R304.5.1, R304.5.3

Possible Solutions:		Compliance	Description	Data	Compliance	Description	Data
Remove & Replace Curb Ramp With Two New Directional Ramps or Equivalent.	N/A	Ramp Length (in)	96.0	Yes	BlendTrans Slope (%)	1.3	
	No	Ramp Width (in)	38.0	No	BlendTrans XSlope (%)	14.0	
	N/A	Flare Type LT	N/A	N/A	Flare Type RT	N/A	
	N/A	Flare Slope LT (%)	N/A	N/A	Flare Slope RT (%)	N/A	
	N/A	Flare Traversable LT?	N/A	N/A	Flare Traversable RT?	N/A	
	N/A	Landing Length (in)	N/A	N/A	DWS Provided?	N/A	
	N/A	Landing Width (in)	N/A	N/A	DWS Contrast?	N/A	
	N/A	Landing Slope (%)	N/A	N/A	DWS Length (in)	N/A	
	N/A	Landing X Slope (%)	N/A	N/A	DWS Full Width?	N/A	
	N/A	Landing Curb? (Y/N)	N/A	N/A	DWS Offset (in)	N/A	
	N/A	Shared Landing?	N/A				
	N/A	Gutter Ponding?	N/A	N/A	Gutter Slope (%)	N/A	
Surveyor Notes: N/A	N/A	Gutter Lip Ht (in)	N/A	N/A	Gutter X Slope (%)	N/A	
	N/A	Painted X Walk1?	No	N/A	Painted X Walk2?	Yes	
		X Walk 1 Direction	To W		X Walk 2 Direction	To SW

X Walk 1 Width (in)	N/A		X Walk 2 Width (in)	52.0	
		X Walk 1 Slope (%)	10.3		X Walk 2 Slope (%)	1.7	
		X Walk 1 X Slope (%)	2.4		X Walk 2 X Slope (%)	8.0	
	N/A	Ramp inside XWalk1?	N/A	N/A	Ramp inside XWalk2?	Yes	
		Road Slope (%)	10.0		Clear Space?	N/A	
		Road X Slope (%)	4.3	N/A	Clear Space to XWalk (in)	N/A	
	N/A	Any Obstructions?	N/A	N/A	Storm Grate/Utility Hazard?	N/A	
		Obstruction Type			Storm Grate/Utility Type		
			N/A			N/A	
PROW/ADA: Not Found, R304.5.1, R304.5.3				Yes	Surface Condition? (G/P)	Good	
				No	Curb Slope (%)	15.3	
Total Cost:	\$	3200.00

Remove & Replace Curb Ramp With Two New Directional Ramps or Equivalent.
