Access Compliance Report

Public Rights-of-Way (Curb Ramps)

Intersection ID: 44935	Main Street: NATHAN_DR	Cross Street: REEDMONT_LN	Location: SW
ADA ID: C6FBF8BBA71C	Ramp Type: Perp	Initial Pass/Fail: Fail	Overall Compliance: No
Severity Score: 21.25			
Codes/Mitigation Info/Possible Solution		Field Measurements/Component Compliance

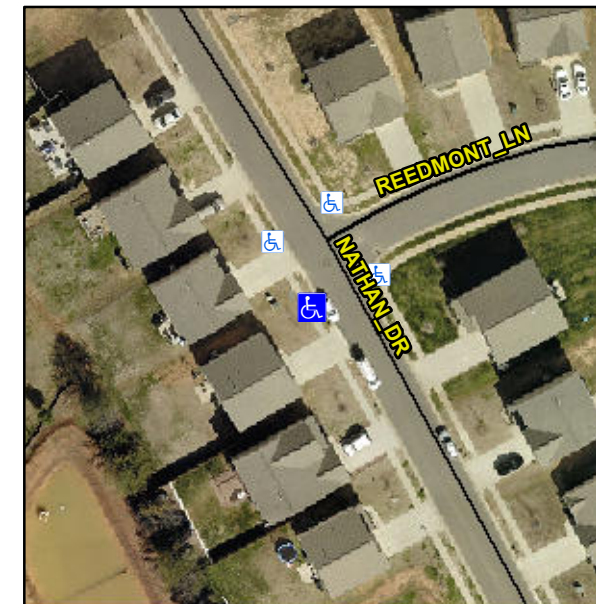
Compliance	Description	Data	Compliance	Description	Data
N/A	Ramp Length (in)	48.0	No	Ramp Slope (%)	10.0
No	Ramp Width (in)	47.5	Yes	Ramp XSlope (%)	0.2
N/A	Flare Type LT	N/A	N/A	Flare Type RT	N/A
N/A	Flare Slope LT (%)	N/A	N/A	Flare Slope RT (%)	N/A
N/A	Flare Traversable LT?	N/A	N/A	Flare Traversable RT?	N/A
N/A	Landing Length (in)	N/A	N/A	DWS Provided?	N/A
N/A	Landing Width (in)	N/A	N/A	DWS Contrast?	N/A
N/A	Landing Slope (%)	N/A	N/A	DWS Length (in)	N/A
N/A	Landing X Slope (%)	N/A	N/A	DWS Full Width?	N/A
N/A	Landing Curb? (Y/N)	N/A	N/A	DWS Offset (in)	N/A
N/A	Shared Landing?	N/A			
N/A	Gutter Ponding?	N/A	N/A	Gutter Slope (%)	N/A
N/A	Gutter Lip Ht (in)	N/A	N/A	Gutter X Slope (%)	N/A
N/A	Painted X Walk1?	No	N/A	Painted X Walk2?	N/A
	X Walk 1 Direction	To E		X Walk 2 Direction	N/A
N/A	X Walk 1 Width (in)	N/A	N/A	X Walk 2 Width (in)	N/A
	X Walk 1 Slope (%)	2.7		X Walk 2 Slope (%)	N/A
	X Walk 1 X Slope (%)	1.4		X Walk 2 X Slope (%)	N/A

N/A	Ramp inside XWalk1?	N/A	N/A	Ramp inside XWalk2?	N/A
	Road Slope (%)	N/A	N/A	Clear Space?	N/A
	Road X Slope (%)	N/A	N/A	Clear Space to XWalk (in)	N/A
N/A	Any Obstructions?	N/A	N/A	Storm Grate/Utility Hazard?	N/A
	Obstruction Type			Storm Grate/Utility Type	
		N/A			N/A
			Yes	Surface Condition? (G/P)	Good

Possible Solutions:

Remove & Replace Entire Ramp.

R304.5.1, R304.2.2
