Access Compliance Report Public Rights-of-Way (Curb Ramps)

Intersection ID: 12653 Main Street: N_MYERS_ST Cross Street: E_8TH_ST Location: W

ADA ID: C700FED1F689 Ramp Type: PerpDiag Initial Pass/Fail: Fail Overall Compliance: No Severity Score: 13.75

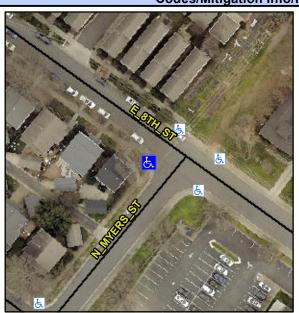
Not Found, R304.2.2, R304.5.3

r leid Measurements/Component Comphance						
Compliance Description		Data	Compliance Description		Data	
N/A	Ramp Length (in)	49.0	No	Ramp Slope (%)	9.8	
Yes	Ramp Width (in)	91.0	No	Ramp XSlope (%)	4.9	
N/A	Flare Type LT	N/A	N/A	Flare Type RT	N/A	
N/A	Flare Slope LT (%)	N/A	N/A	Flare Slope RT (%)	N/A	
N/A	Flare Traversable LT?	N/A	N/A	Flare Traversable RT?	N/A	
N/A	Landing Length (in)	N/A	N/A	DWS Provided?	N/A	
N/A	Landing Width (in)	N/A	N/A	DWS Contrast?	N/A	
N/A	Landing Slope (%)	N/A	N/A	DWS Length (in)	N/A	
N/A	Landing X Slope (%)	N/A	N/A	DWS Full Width?	N/A	
N/A	Landing Curb? (Y/N)	N/A	N/A	DWS Offset (in)	N/A	
N/A	Shared Landing?	N/A				
N/A	Gutter Ponding?	N/A	N/A	Gutter Slope (%)	N/A	
N/A	Gutter Lip Ht (in)	N/A	N/A	Gutter X Slope (%)	N/A	
N/A	Painted X Walk1?	No	N/A	Painted X Walk2?	No	
	X Walk 1 Direction	To SE		X Walk 2 Direction	To NE	
N/A	X Walk 1 Width (in)	N/A	N/A	X Walk 2 Width (in)	N/A	
	X Walk 1 Slope (%)	0.8		X Walk 2 Slope (%)	2.0

X Walk 1 X Slope (%)	7.3		X Walk 2 X Slope (%)	4.1	
N/A	Ramp inside XWalk1?	N/A	N/A	Ramp inside XWalk2?	N/A	
	Road Slope (%)	2.4	N/A	Clear Space?	N/A	
	Road X Slope (%)	3.2	N/A	Clear Space to XWalk (in)	N/A	
N/A	Any Obstructions?	N/A	N/A	Storm Grate/Utility Hazard?	N/A	
			1

N MYERS ST StopSign E 8TH ST None Possible Solutions:

Remove & Replace Curb Ramp With Two New Directional Ramps or Equivalent.
