# Access Compliance Report

## Public Rights-of-Way

### (Curb Ramps)

Intersection ID: 10023454	Main Street: CIERA_NICHOLE_CT	Cross Street: N/A	Location: W
ADA ID: C7024B8B68C9	Ramp Type: Perp	Initial Pass/Fail: Fail	Overall Compliance: No
Codes/Mitigation Info/Possible Solution		Field Measurements/Component Compliance	
Severity Score: 31.25

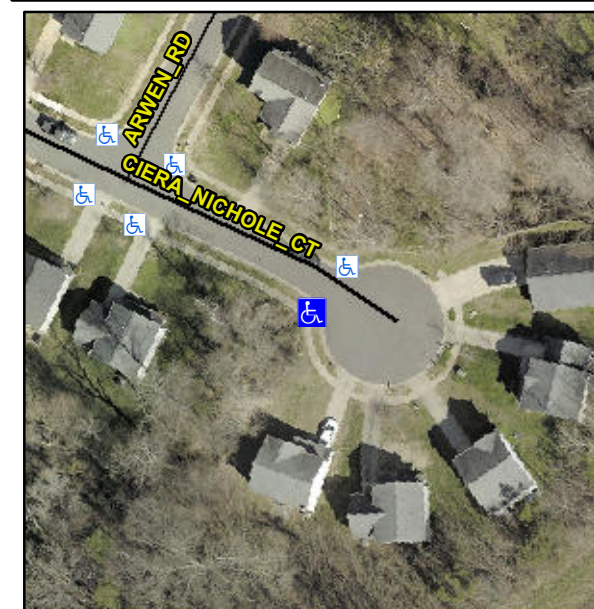
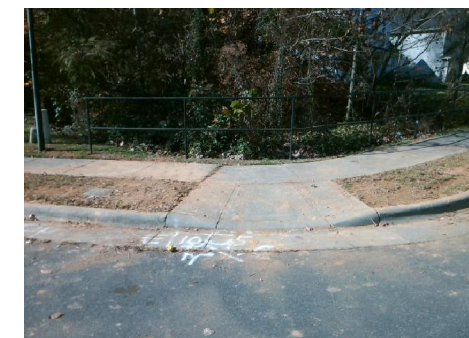
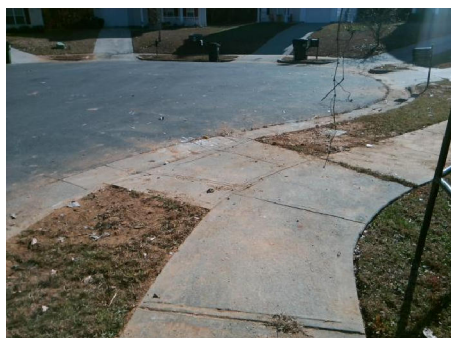
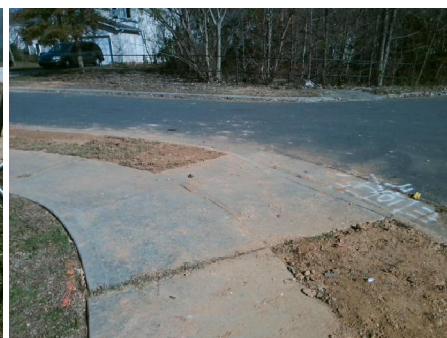
**Not Found, R304.5.1, R304.2.2, R304.5.3**

Compliance	Description	Data	Compliance	Description	Data
N/A	Ramp Length (in)	49.0	No	Ramp Slope (%)	9.7
No	Ramp Width (in)	35.5	No	Ramp XSlope (%)	4.4
N/A	Flare Type LT	N/A	N/A	Flare Type RT	N/A
N/A	Flare Slope LT (%)	N/A	N/A	Flare Slope RT (%)	N/A
N/A	Flare Traversable LT?	N/A	N/A	Flare Traversable RT?	N/A
N/A	Landing Length (in)	N/A	N/A	DWS Provided?	N/A
N/A	Landing Width (in)	N/A	N/A	DWS Contrast?	N/A
N/A	Landing Slope (%)	N/A	N/A	DWS Length (in)	N/A
N/A	Landing X Slope (%)	N/A	N/A	DWS Full Width?	N/A
N/A	Landing Curb? (Y/N)	N/A	N/A	DWS Offset (in)	N/A
N/A	Shared Landing?	N/A			
N/A	Gutter Ponding?	N/A	N/A	Gutter Slope (%)	N/A
N/A	Gutter Lip Ht (in)	N/A	N/A	Gutter X Slope (%)	N/A
N/A	Painted X Walk1?	No	N/A	Painted X Walk2?	N/A
	X Walk 1 Direction	To NE		X Walk 2 Direction	N/A
N/A	X Walk 1 Width (in)	N/A	N/A	X Walk 2 Width (in)	N/A
	X Walk 1 Slope (%)	5.0		X Walk 2 Slope (%)	N/A
	X Walk 1 X Slope (%)	1.3		X Walk 2 X Slope (%)	N/A

N/A	Ramp inside XWalk1?	N/A	N/A	Ramp inside XWalk2?	N/A
	Road Slope (%)	N/A	N/A	Clear Space?	N/A
	Road X Slope (%)	N/A	N/A	Clear Space to XWalk (in)	N/A
N/A	Any Obstructions?	N/A	N/A	Storm Grate/Utility Hazard?	N/A
	Obstruction Type			Storm Grate/Utility Type	
		N/A			N/A
			Yes	Surface Condition? (G/P)	Good

**Remove & Replace Entire Ramp.**
