Access Compliance Report

Public Rights-of-Way

(Curb Ramps)

Intersection ID: 50619	Main Street: COTTON_GUM_RD	Cross Street: YELLOW_OAK_RD	Location: SE
ADA ID: C70667D39ADA	Ramp Type: Perp	Initial Pass/Fail: Fail	Overall Compliance: No
Severity Score: 12.5			
Codes/Mitigation Info/Possible Solution		Field Measurements/Component Compliance

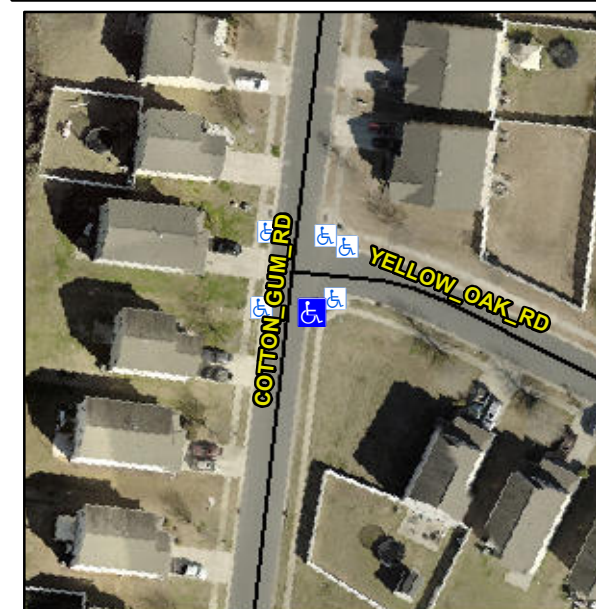
Compliance	Description	Data	Compliance	Description	Data
N/A	Ramp Length (in)	47.0	No	Ramp Slope (%)	9.0
Yes	Ramp Width (in)	48.0	Yes	Ramp XSlope (%)	1.1
N/A	Flare Type LT	N/A	N/A	Flare Type RT	N/A
N/A	Flare Slope LT (%)	N/A	N/A	Flare Slope RT (%)	N/A
N/A	Flare Traversable LT?	N/A	N/A	Flare Traversable RT?	N/A
N/A	Landing Length (in)	N/A	N/A	DWS Provided?	N/A
N/A	Landing Width (in)	N/A	N/A	DWS Contrast?	N/A
N/A	Landing Slope (%)	N/A	N/A	DWS Length (in)	N/A
N/A	Landing X Slope (%)	N/A	N/A	DWS Full Width?	N/A
N/A	Landing Curb? (Y/N)	N/A	N/A	DWS Offset (in)	N/A
N/A	Shared Landing?	N/A			
N/A	Gutter Ponding?	N/A	N/A	Gutter Slope (%)	N/A
N/A	Gutter Lip Ht (in)	N/A	N/A	Gutter X Slope (%)	N/A
N/A	Painted X Walk1?	No	N/A	Painted X Walk2?	N/A
	X Walk 1 Direction	To W		X Walk 2 Direction	N/A
N/A	X Walk 1 Width (in)	N/A	N/A	X Walk 2 Width (in)	N/A
	X Walk 1 Slope (%)	2.8		X Walk 2 Slope (%)	N/A
	X Walk 1 X Slope (%)	3.2		X Walk 2 X Slope (%)	N/A

N/A	Ramp inside XWalk1?	N/A	N/A	Ramp inside XWalk2?	N/A
	Road Slope (%)	N/A	N/A	Clear Space?	N/A
	Road X Slope (%)	N/A	N/A	Clear Space to XWalk (in)	N/A
N/A	Any Obstructions?	N/A	N/A	Storm Grate/Utility Hazard?	N/A
	Obstruction Type			Storm Grate/Utility Type	
		N/A			N/A
		Yes		Surface Condition? (G/P)	Good

Possible Solutions:

Remove & Replace Entire Ramp.
