# Access Compliance Report

## Public Rights-of-Way

### (Curb Ramps)

| Intersection ID: 44480 | Main Street: LOYALIST_ST | Cross Street: REDDING_GLEN_AV | Location: NE |

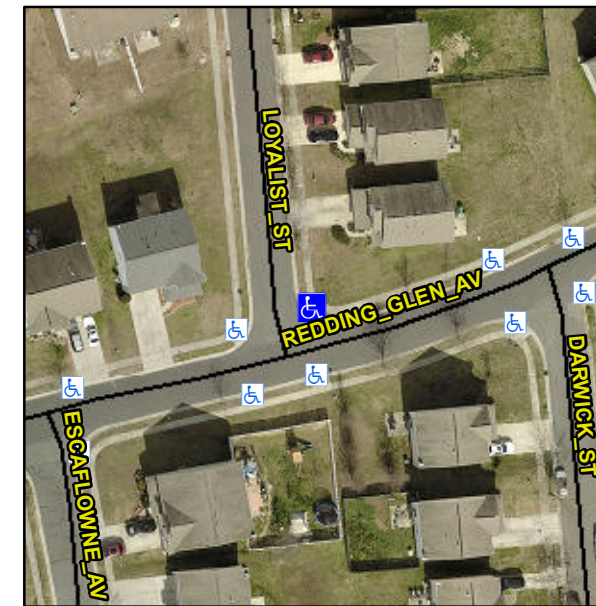
| ADA ID: C709D1D1A145 | Ramp Type: BlendTrans1 | Initial Pass/Fail: Fail | Overall Compliance: No |
| Codes/Mitigation Info/Possible Solution | | | Severity Score: 25 |

**Not Found, R304.5.3**

| Compliance | Description | Data | Compliance | Description | Data |
|---|---|---|---|---|---|
| Yes | Ramp Width (in) | 48.0 | No | BlendTrans XSlope (%) | 8.4 |
| | | | No | Curb Slope (%) | 13.1 |

**Remove & Replace Curb Ramp With Two New Directional Ramps or Equivalent.**

Total Cost: \$ 3200.00
