# Access Compliance Report

## Public Rights-of-Way

### (Curb Ramps)

Intersection ID: 16160	Main Street: MARSH_RD	Cross Street: WRISTON_PL	Location: NE
ADA ID: C70BBA10441F	Ramp Type: Perp	Initial Pass/Fail: Fail	Overall Compliance: No
Severity Score: 25			
Codes/Mitigation Info/Possible Solution		Field Measurements/Component Compliance

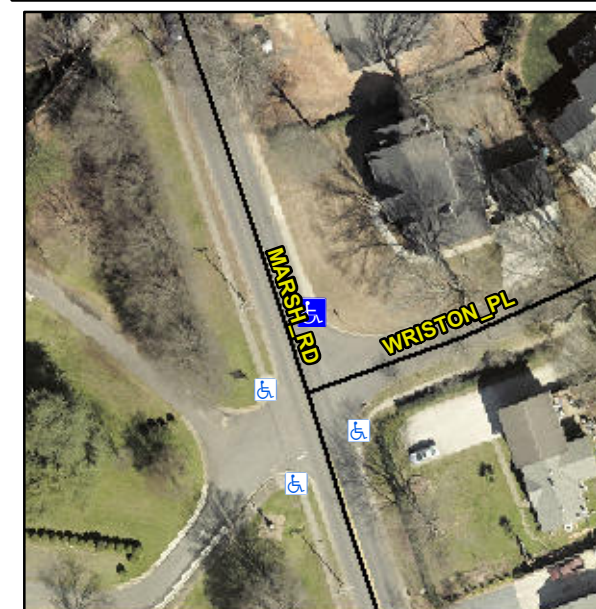
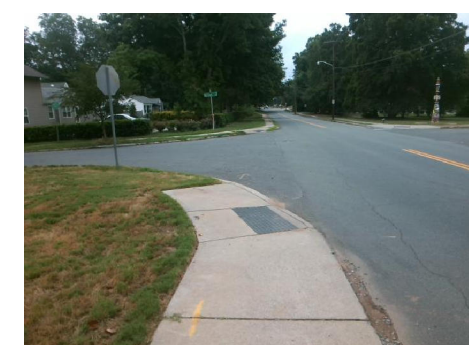
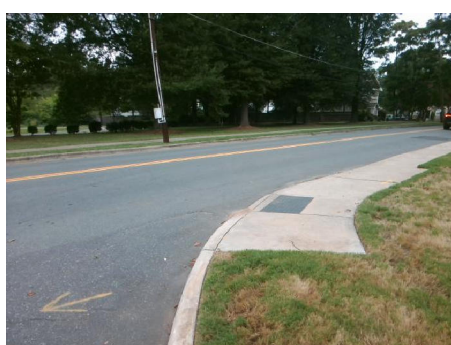
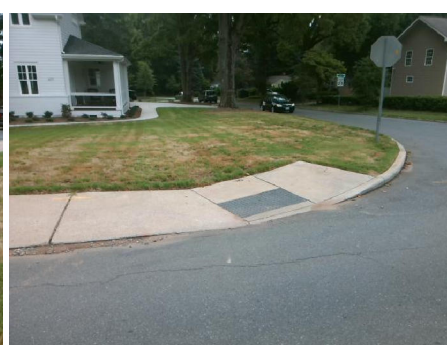
Compliance	Description	Data	Compliance	Description	Data
N/A	Ramp Length (in)	60.0	Yes	Ramp Slope (%)	7.7
Yes	Ramp Width (in)	48.0	No	Ramp XSlope (%)	7.7
N/A	Flare Type LT	N/A	N/A	Flare Type RT	N/A
N/A	Flare Slope LT (%)	N/A	N/A	Flare Slope RT (%)	N/A
N/A	Flare Traversable LT?	N/A	N/A	Flare Traversable RT?	N/A
N/A	Landing Length (in)	N/A	N/A	DWS Provided?	N/A
N/A	Landing Width (in)	N/A	N/A	DWS Contrast?	N/A
N/A	Landing Slope (%)	N/A	N/A	DWS Length (in)	N/A
N/A	Landing X Slope (%)	N/A	N/A	DWS Full Width?	N/A
N/A	Landing Curb? (Y/N)	N/A	N/A	DWS Offset (in)	N/A
N/A	Shared Landing?	N/A			
N/A	Gutter Ponding?	N/A	N/A	Gutter Slope (%)	N/A
N/A	Gutter Lip Ht (in)	N/A	N/A	Gutter X Slope (%)	N/A
N/A	Painted X Walk1?	No	N/A	Painted X Walk2?	N/A
	X Walk 1 Direction	To SW		X Walk 2 Direction	N/A
N/A	X Walk 1 Width (in)	N/A	N/A	X Walk 2 Width (in)	N/A
	X Walk 1 Slope (%)	6.1		X Walk 2 Slope (%)	N/A
	X Walk 1 X Slope (%)	0.6		X Walk 2 X Slope (%)	N/A

N/A	Ramp inside XWalk1?	N/A	N/A	Ramp inside XWalk2?	N/A
	Road Slope (%)	N/A	N/A	Clear Space?	N/A
	Road X Slope (%)	N/A	N/A	Clear Space to XWalk (in)	N/A
N/A	Any Obstructions?	N/A	N/A	Storm Grate/Utility Hazard?	N/A
	Obstruction Type			Storm Grate/Utility Type	
		N/A			N/A
			Yes	Surface Condition? (G/P)	Good

**Remove & Replace Entire Ramp.**

**Not Found, R304.5.3**
