Access Compliance Report

Public Rights-of-Way

(Curb Ramps)

Intersection ID: 20720	Main Street: COVEDALE_DR	Cross Street: SARDIS_COVE_DR	Location: W
ADA ID: C710C1841BB9	Ramp Type: PerpDiag	Initial Pass/Fail: Fail	Overall Compliance: No
		Severity Score: 25

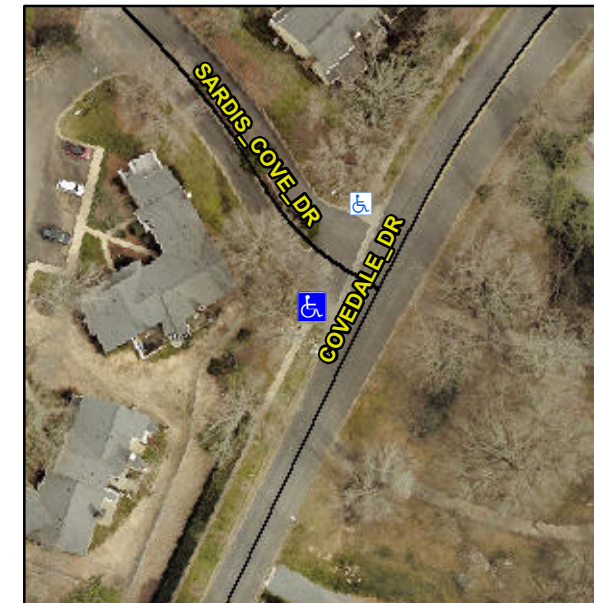
Compliance	Description	Data	Compliance	Description	Data
N/A	Ramp Length (in)	91.0	No	Ramp Slope (%)	20.0
Yes	Ramp Width (in)	48.0	Yes	Ramp XSlope (%)	1.3
N/A	Flare Type LT	N/A	N/A	Flare Type RT	N/A
N/A	Flare Slope LT (%)	N/A	N/A	Flare Slope RT (%)	N/A
N/A	Flare Traversable LT?	N/A	N/A	Flare Traversable RT?	N/A
N/A	Landing Length (in)	N/A	N/A	DWS Provided?	N/A
N/A	Landing Width (in)	N/A	N/A	DWS Contrast?	N/A
N/A	Landing Slope (%)	N/A	N/A	DWS Length (in)	N/A
N/A	Landing X Slope (%)	N/A	N/A	DWS Full Width?	N/A
N/A	Landing Curb? (Y/N)	N/A	N/A	DWS Offset (in)	N/A
N/A	Shared Landing?	N/A			
N/A	Gutter Ponding?	N/A	N/A	Gutter Slope (%)	N/A
N/A	Gutter Lip Ht (in)	N/A	N/A	Gutter X Slope (%)	N/A
N/A	Painted X Walk1?	No	N/A	Painted X Walk2?	No
	X Walk 1 Direction	To SE		X Walk 2 Direction	To NE
N/A	X Walk 1 Width (in)	N/A	N/A	X Walk 2 Width (in)	N/A
	X Walk 1 Slope (%)	3.4		X Walk 2 Slope (%)	3.8
	X Walk 1 X Slope (%)	1.3		X Walk 2 X Slope (%)	6.8

N/A	Ramp inside XWalk1?	N/A	N/A	Ramp inside XWalk2?	N/A
	Road Slope (%)	7.2	N/A	Clear Space?	N/A
	Road X Slope (%)	0.1	N/A	Clear Space to XWalk (in)	N/A
N/A	Any Obstructions?	N/A	N/A	Storm Grate/Utility Hazard?	N/A
	Obstruction Type			Storm Grate/Utility Type	
		N/A			N/A
			Yes	Surface Condition? (G/P)	Good

Remove & Replace Curb Ramp With Two New Directional Ramps or Equivalent.

R304.2.2
